PC-9 Ageing Aircraft Challenges

Wing Commander Ashley Howell
Commanding Officer
Air Training and Aviation Commons System Program Office

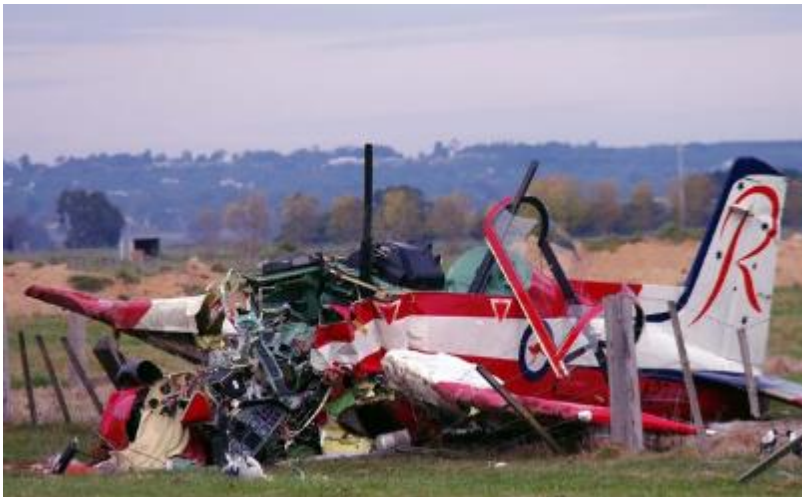
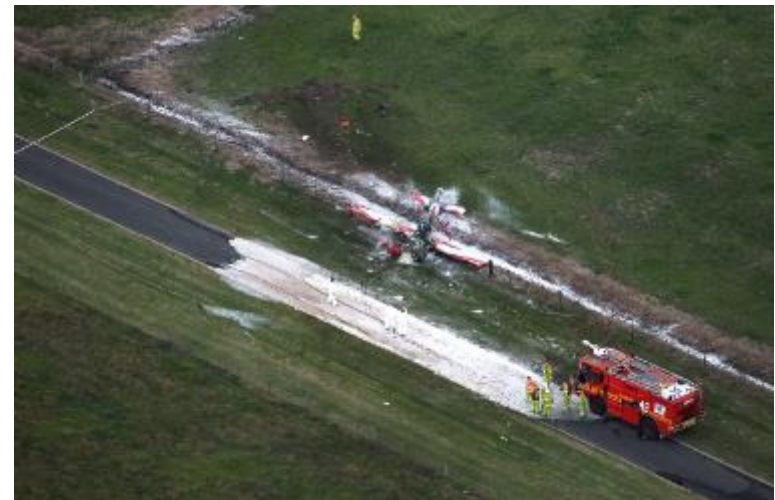
- Failure mode consistent with the cause of the May 2011 crash of A23-039; undetected wear failure of the HPFP driveshaft spline.
- The engine failure occurred 3nm from the RW04 RAAF East Sale at approx. 3,600ft AGL.

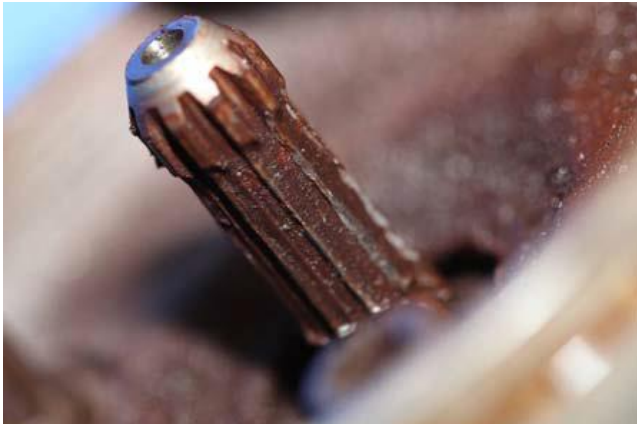
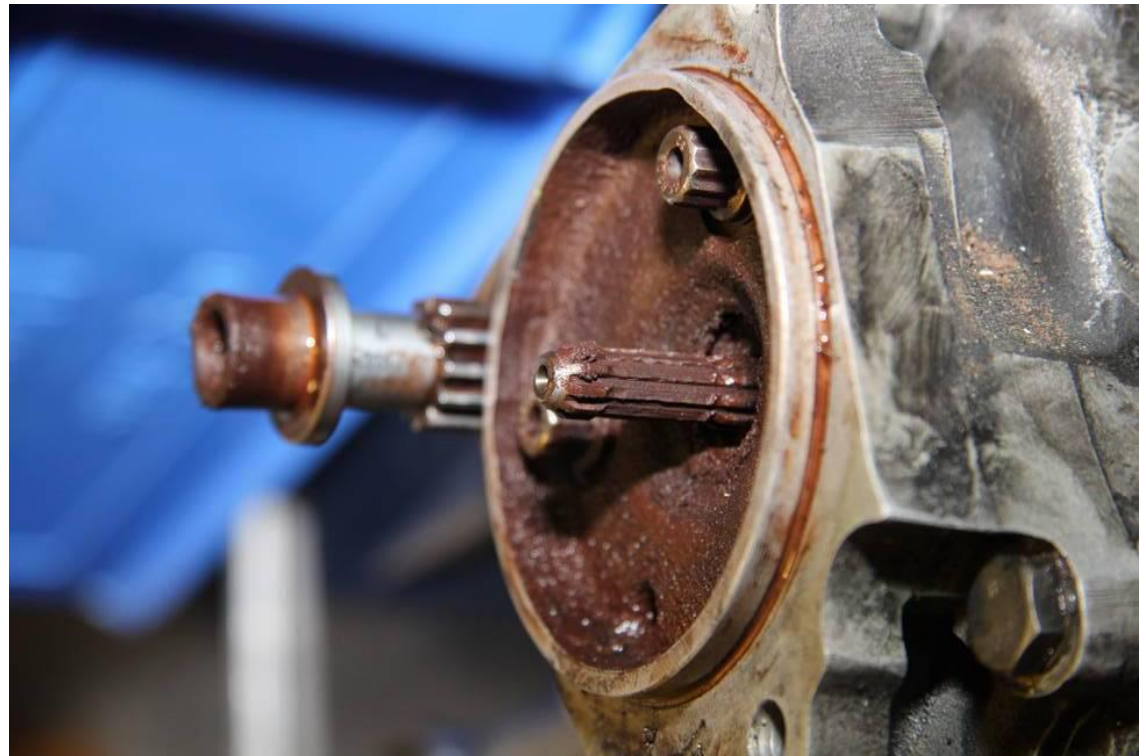
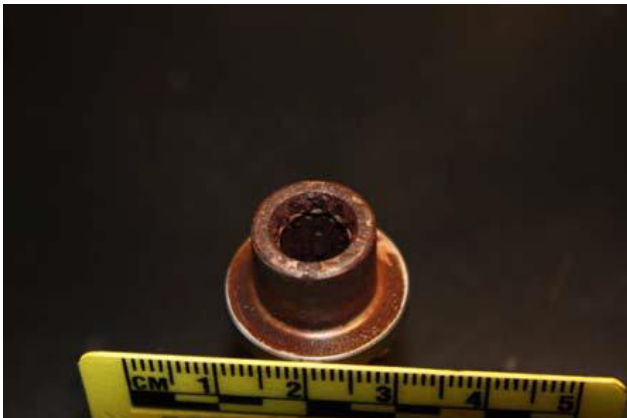
A23-039 HPFP

- DSTG analysis identified the composition of the black substance was consistent with fretting debris from the coupling mixed with lubricating oil, specifically being comprised of carbon with metallic components consistent with the steel coupling alloy AMS6470 and chromium plating.
- This fretting wear can be self-accelerating. The wear rate was not predictable.

- Engineering actions:
 - Maintenance policy update to include swab testing at 300ENHRs to check for wear debris (OEM policy BS1 500ENHRs, BS2 1,500ENHRs).
 - Fleet HPFP In-situ Inspections carried out.
 - Incorporation of a modification to replace the existing Sundstrand pumps with Argo-tech HPFPs.

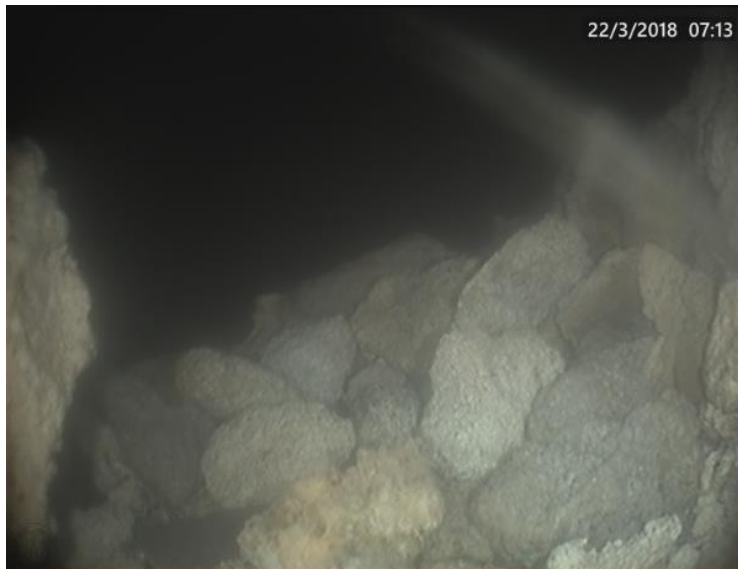
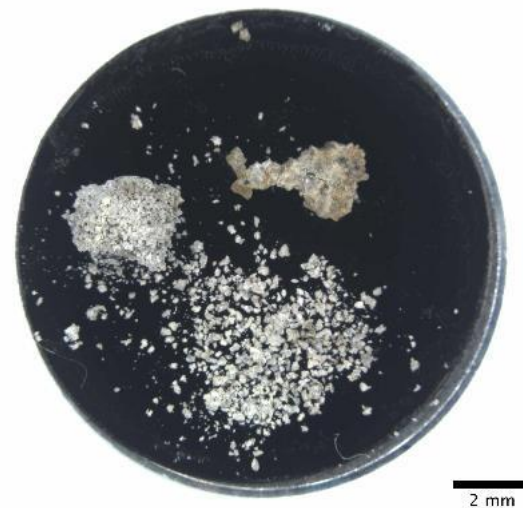
- During a S40 servicing (compressor wash) a gravel/ceramic substance discovered in the turbine case drain hole.
- Initially thought to be desiccant.

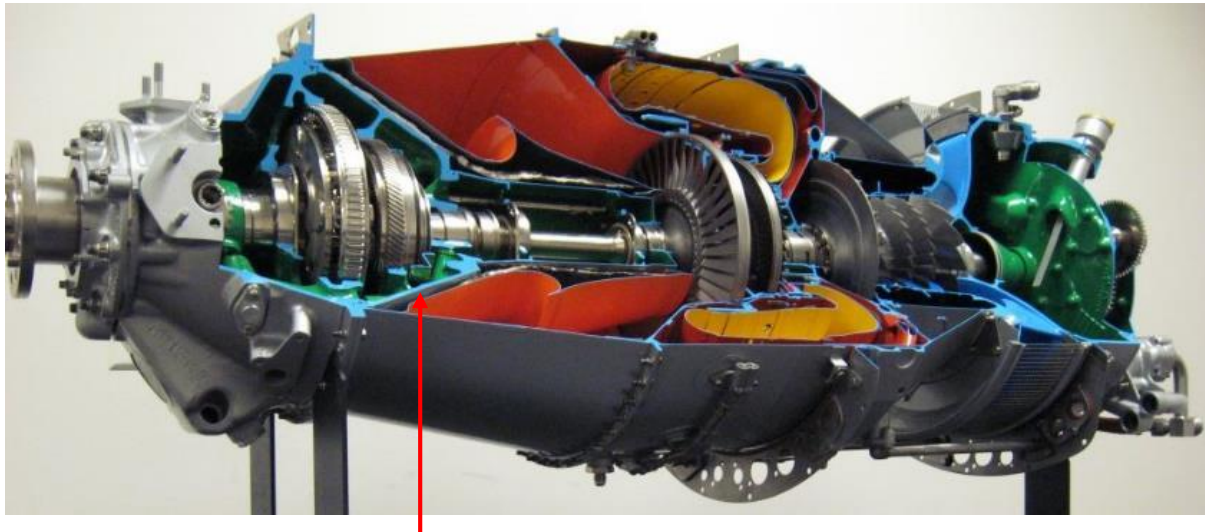
RGB Rear Case

- The substance was analysed by DSTG and identified as Magnesium Oxide.
- In addition, the WDA identified purple flakes in the oil patch test. DSTG analysis identified this to be Quinizarate.

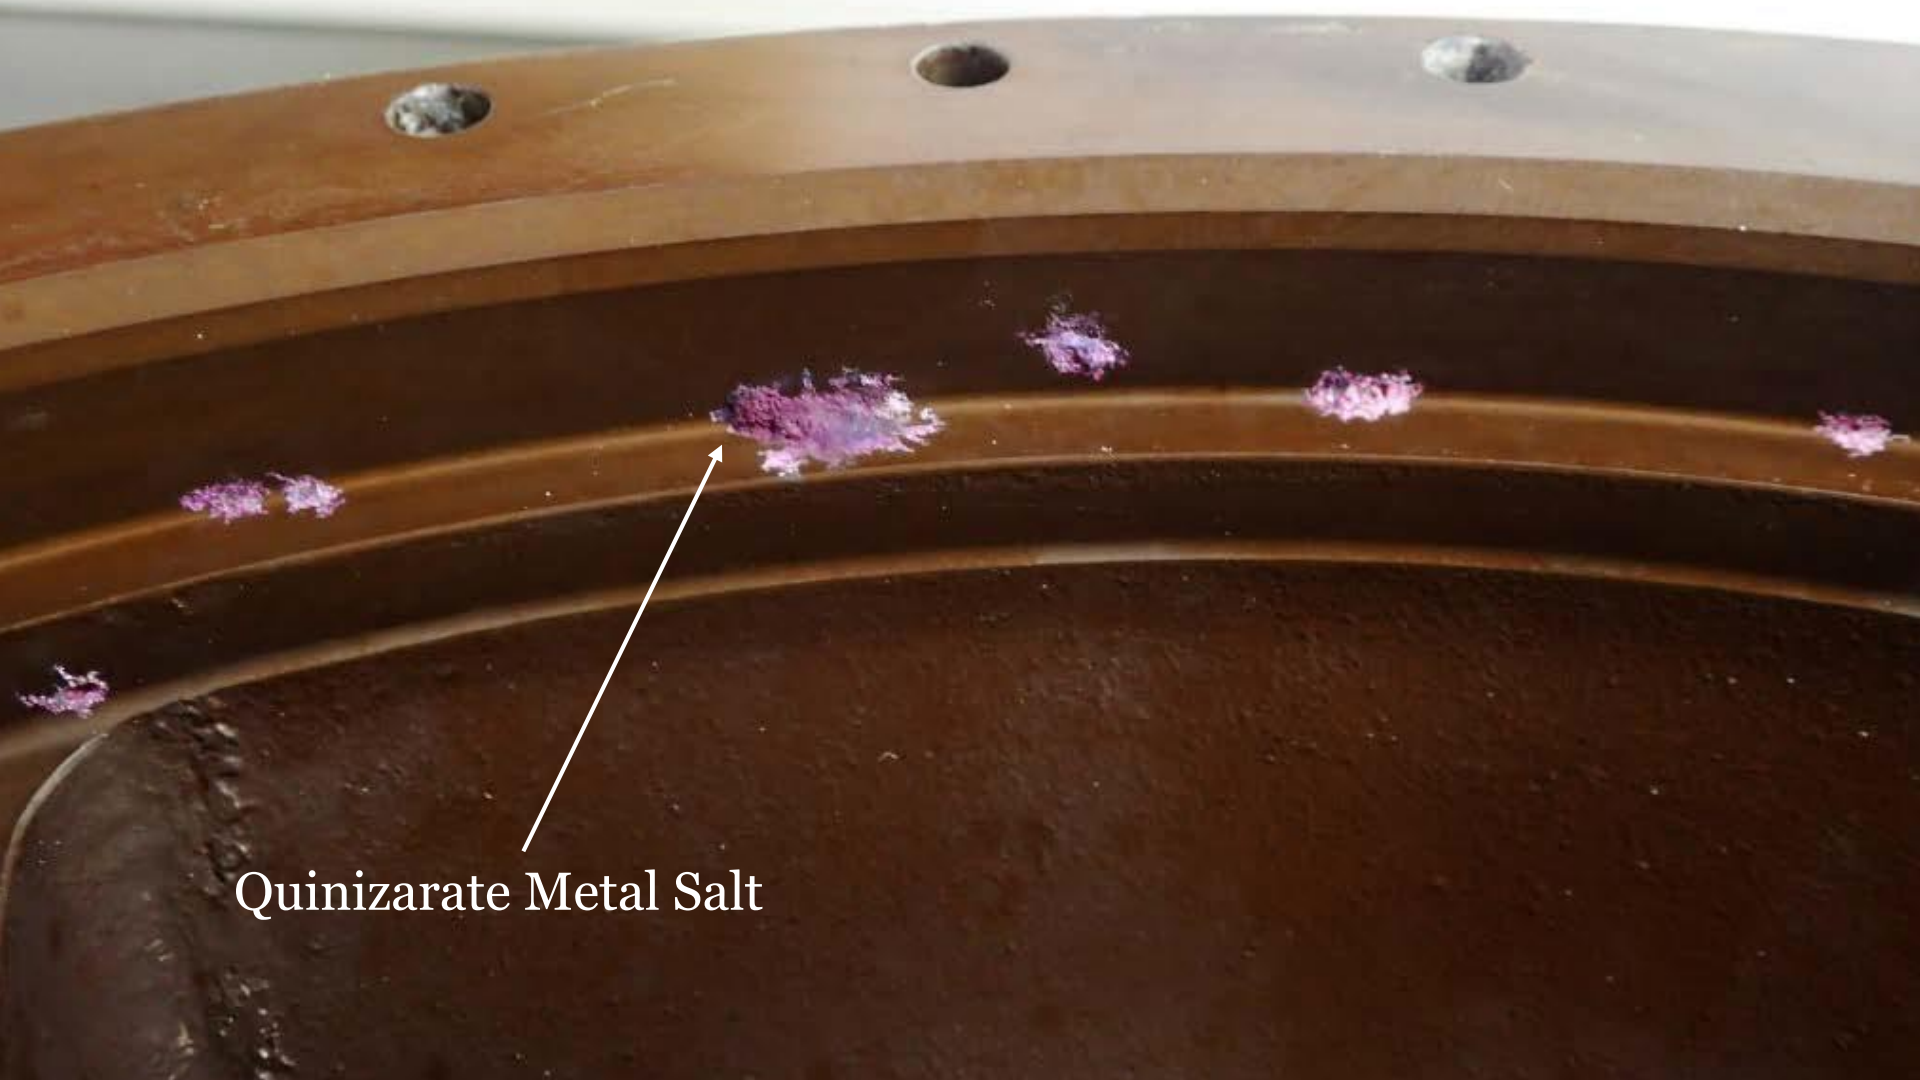
Quinizarate Metal Salt

- Quinizarate metal salt occurs when oil containing quinizarin reacts with magnesium oxide.
- The presence of quinizarate metal salt on the outside of the RGB rear case confirmed that the corrosion has penetrated the case in several areas.

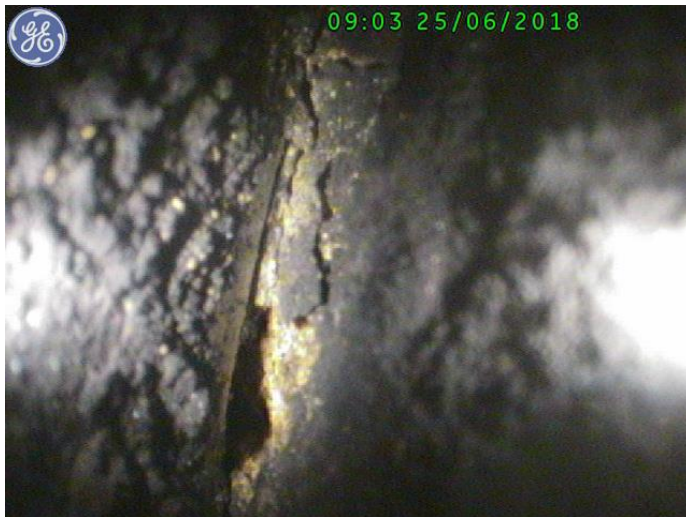
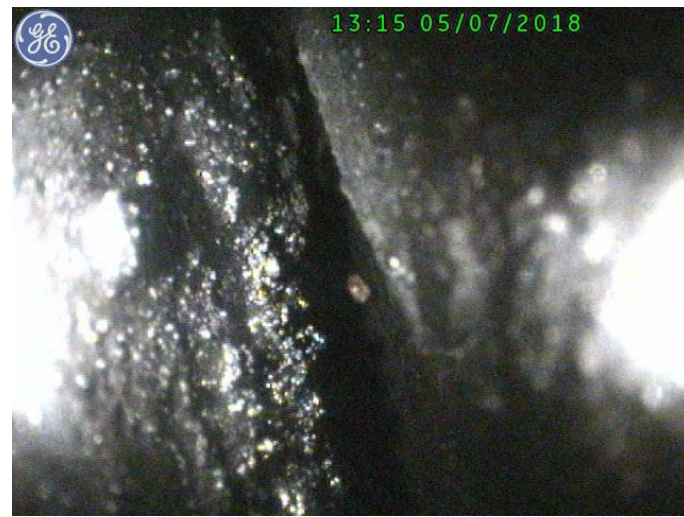
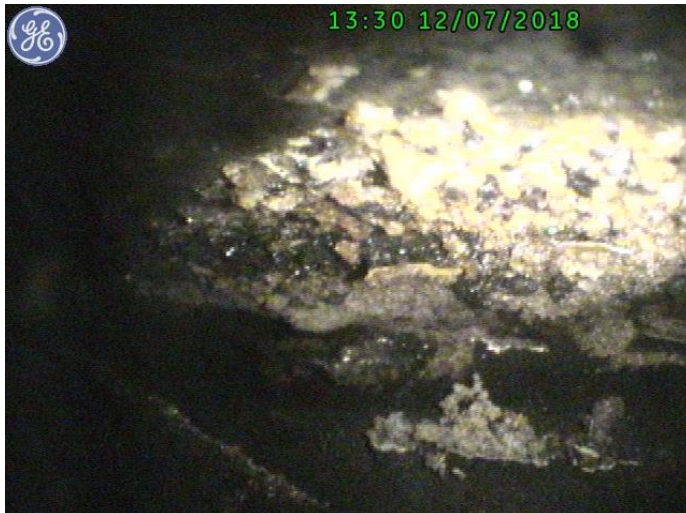
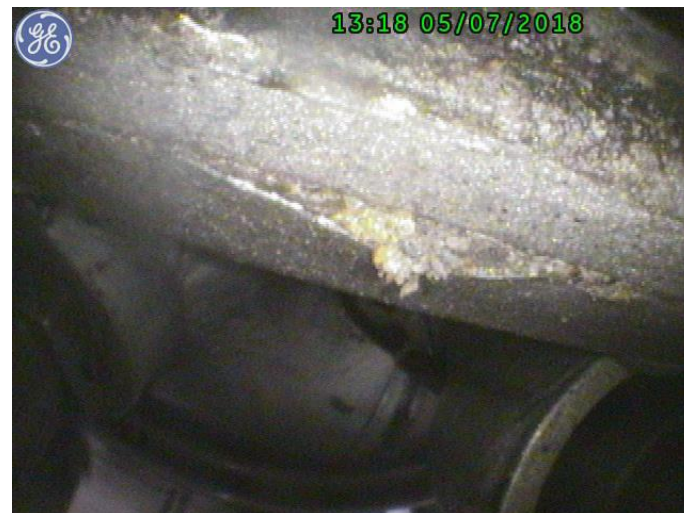
The inspections identified five engines which presented risk factors that required further inspection at an engine repair facility.

- Engineering actions:
 - Teardown of U/S engines conducted to gain an understanding of fleet condition.
 - ATACSPO purchased borescopes for each unit to conduct INAM inspections (protecting expensive units).
 - ATACSPO ranked all engines based upon operating hours, periods of inactivity both installed and uninstalled and results of borescope inspections.
 - Additional engines were inducted into repair.
