Repair of aircraft components with Additive Manufacturing Laser Cladding Technology – Examples and Modelling

Kevin Walker¹, Qianchu Liu¹ and Tim Cooper²

AA&S Conference

Brisbane, Australia, 19-21 July 2017

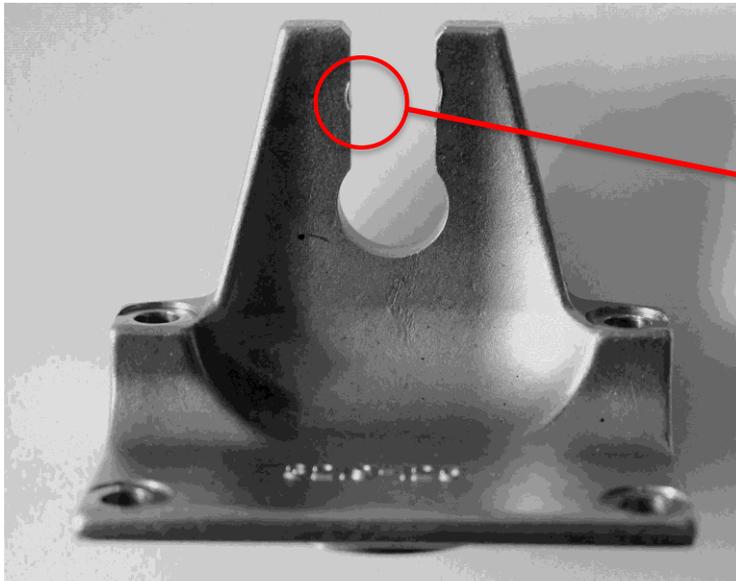
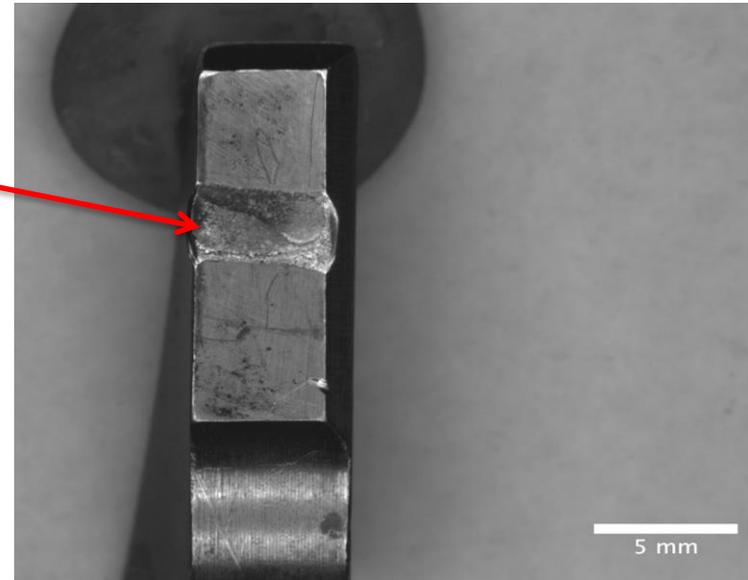
F/A-18 Rudder Anti-Rotation Bracket

- Unserviceable damage due to wear
- Precipitation-hardened stainless steel 17-4 PH
- Geometrical restoration (No post heat treatment)
- Clad hardness to match component

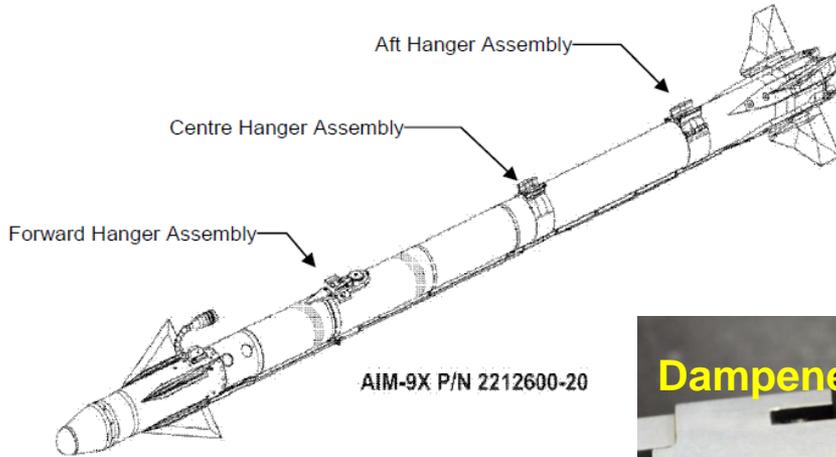
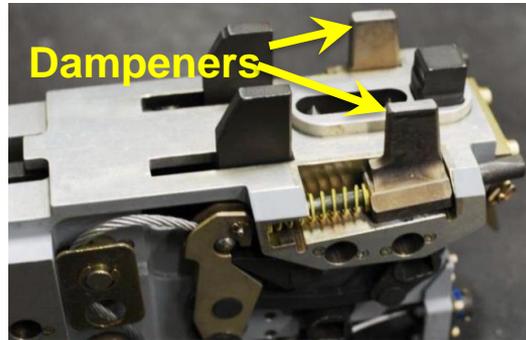
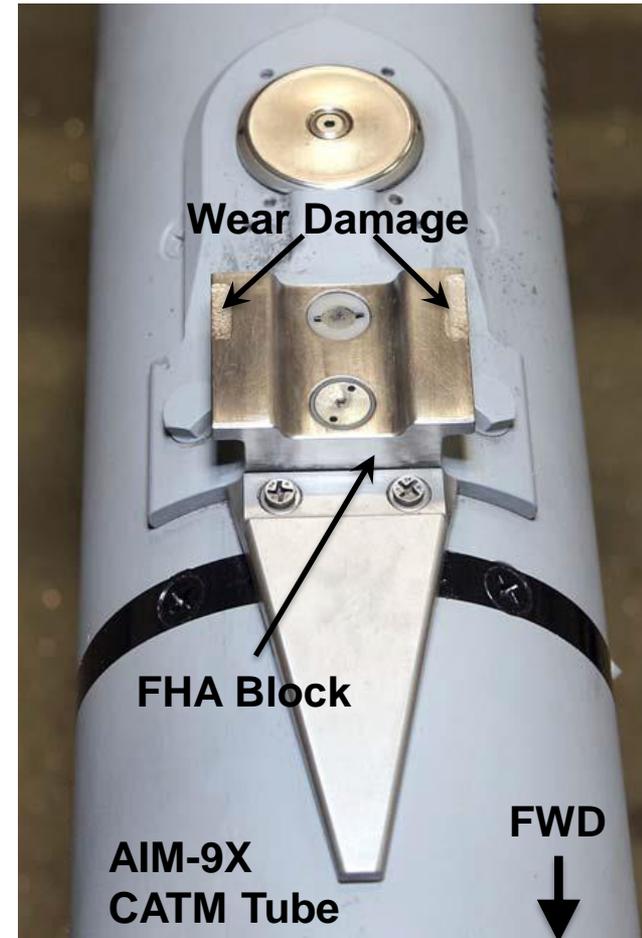
F/A-18F AIM-9X Missile Forward Hanger Assembly

- Unserviceable damage due to wear
- Dampeners causing flange wear damage
- Allowable flange tolerance 0.25 mm
- Geometry restoration

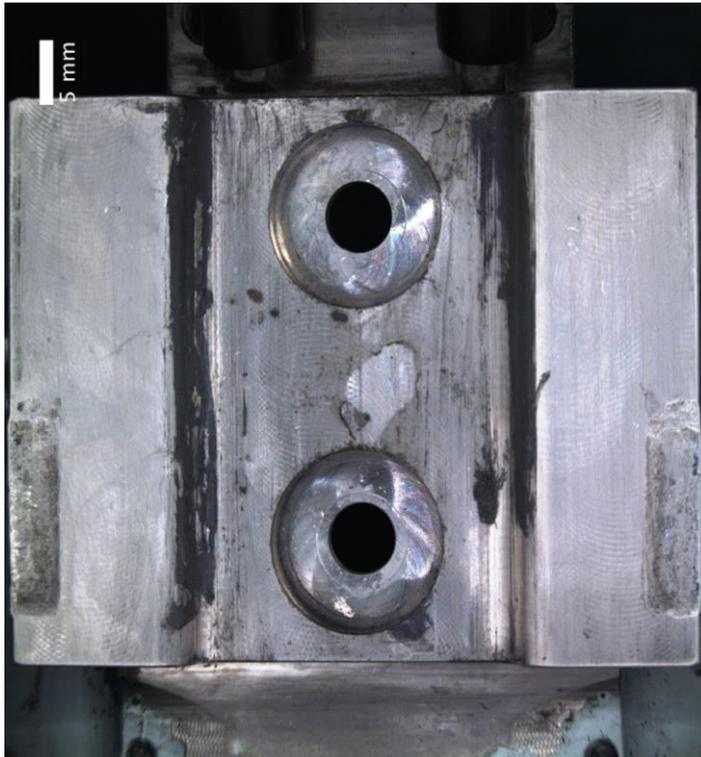
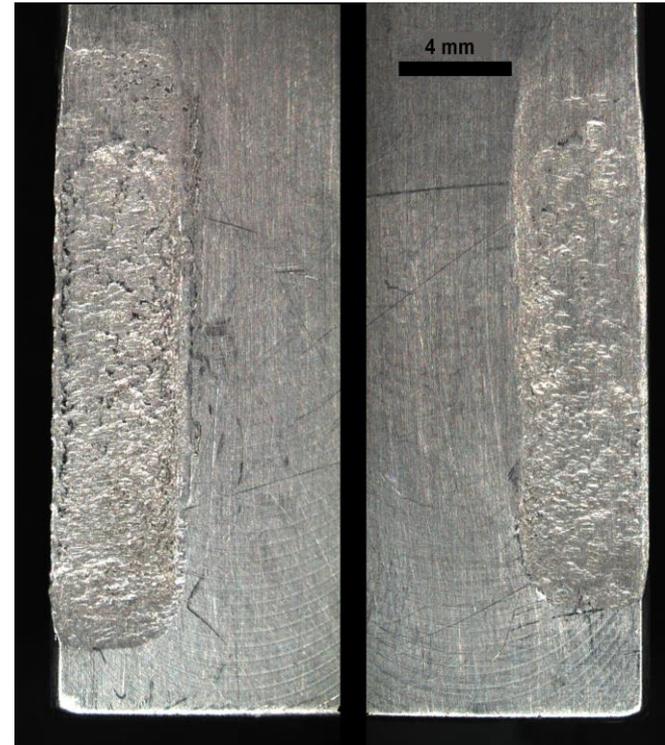
Repair of F/A-18F Forward Hanger Assembly

Damaged by Wear

Material: Cast PH13-8 stainless steel

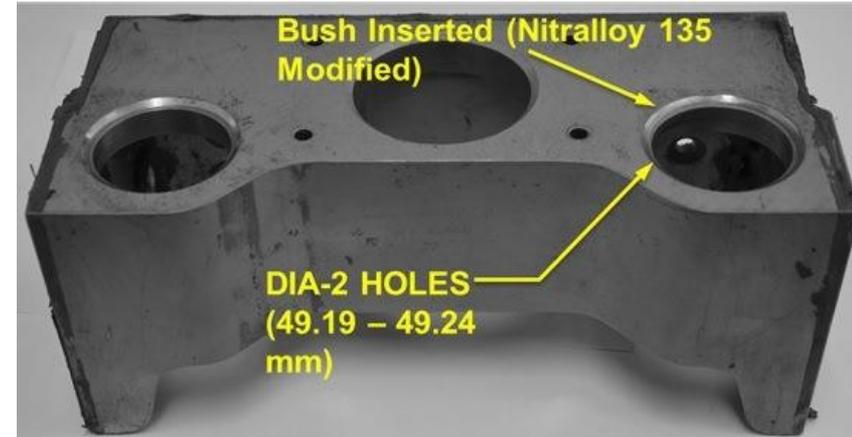
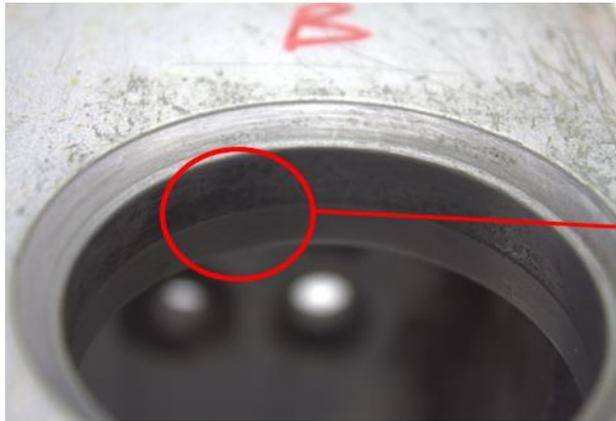
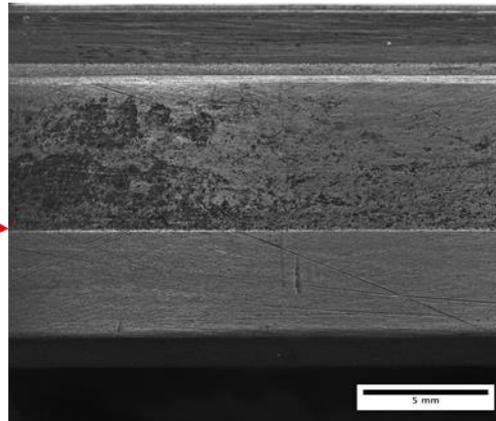
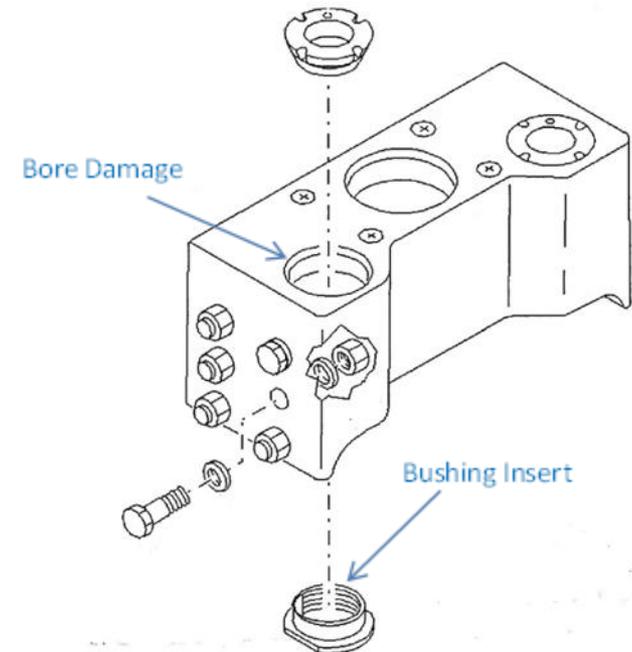
C-130J Landing Gear Shelf Bracket Details

- 4140 steel forging
- Corrosion in drag pin holes
- Corrosion damage depth limit is very conservative – maximum allowable depth 12 μm , 0.0005 in
- Typically find 3 out of 4 brackets need to be replaced at 6 yearly depot servicing

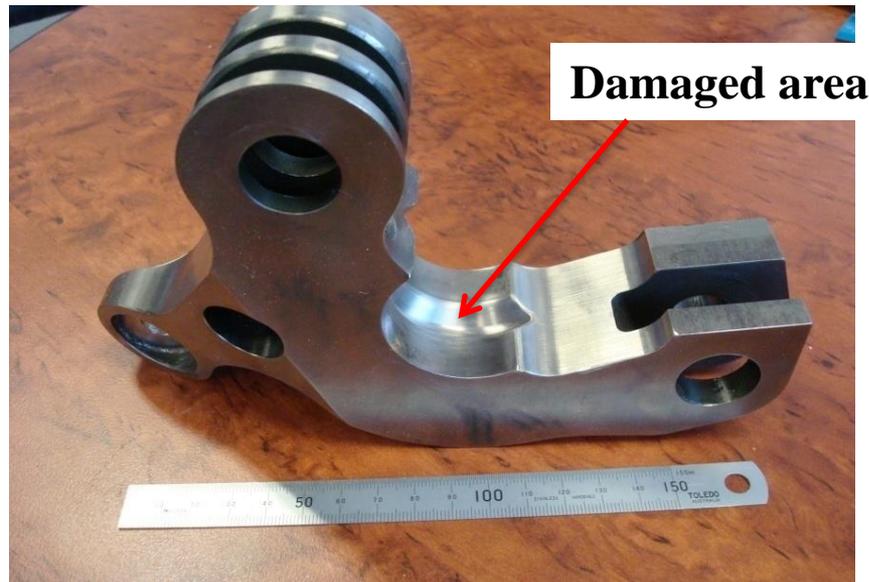
Repair of F/A-18 Engine Mount

- Unserviceable damage due to wear
- Titanium Alloy (Ti-6Al-4V)
- Geometrical restoration (No post heat treatment)

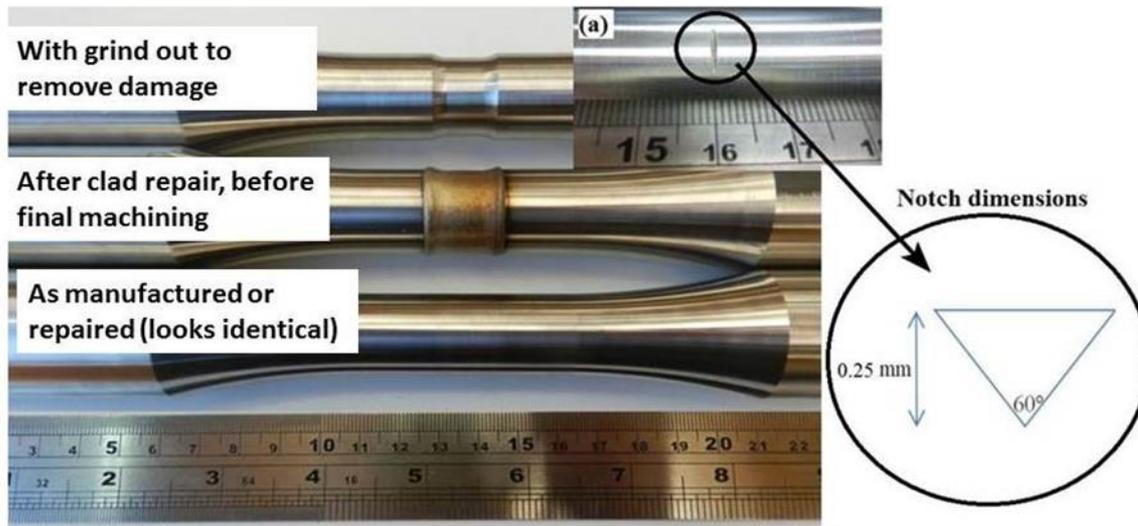
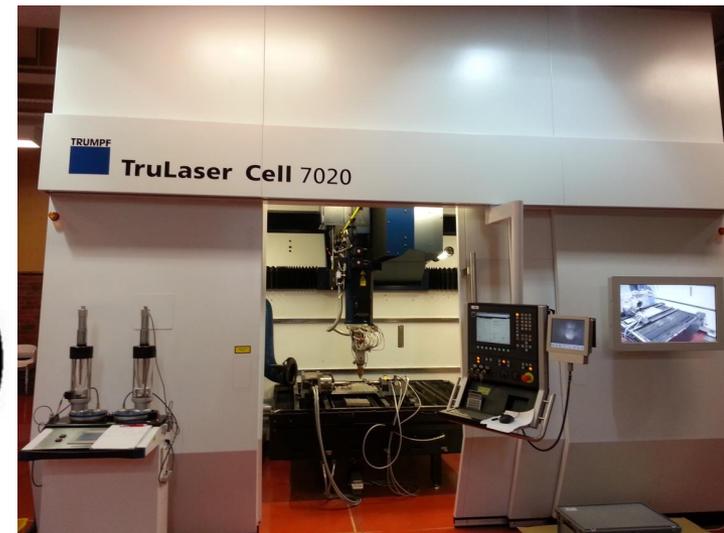
Structural Repair of AerMet[®]100 Steel

- AerMet[®]100 32/20 mm dia round bar samples
- 0.25 mm deep crack starter
- 0.5 mm deep, 10 mm long groove, repaired by cladding with TRUMPF TrueLaser Cell 7020 System

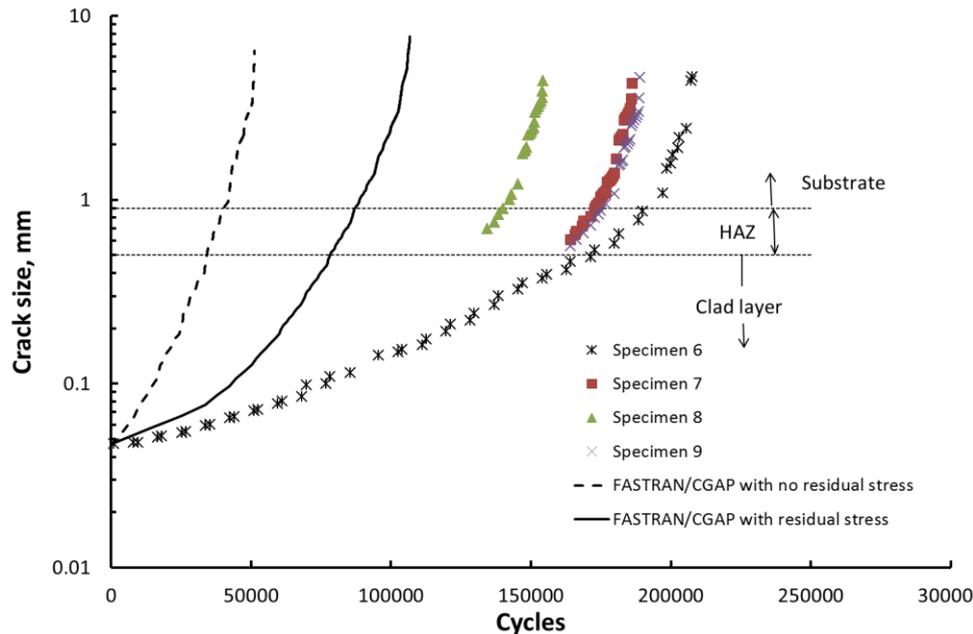
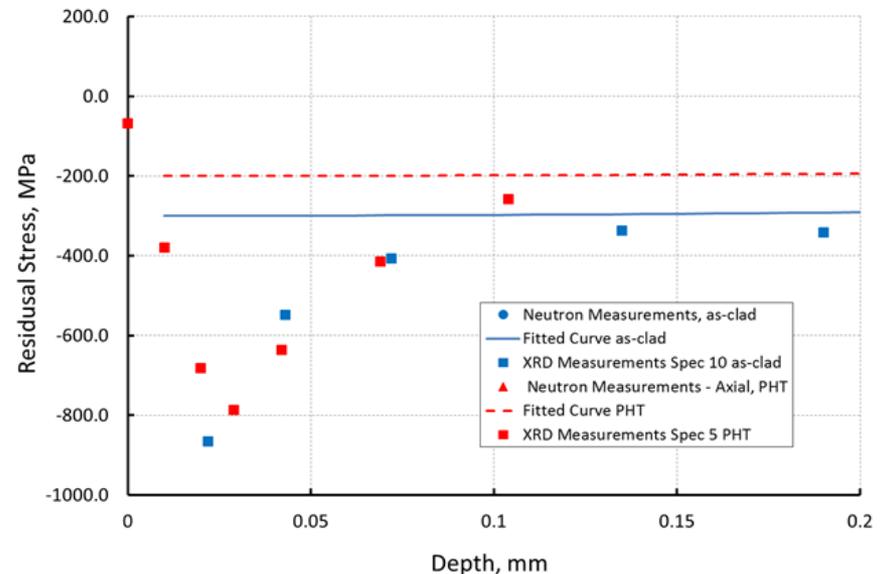
Crack Behaviour & Prediction:

- Slow fatigue crack growth due to the compressive residual stress in clad layer
- Ability to restore strength and fatigue life is very promising
- Crack growth modelling being updated with recent X-Ray diffraction results – expect an improvement
- Ability to model the residual stress behaviour will greatly improve our capability to design these structural repairs – to be discussed next by Tim Cooper
