Surveying high-energy piping hangers

Using a proprietary camera system to undertake accurate hot and cold hanger surveys

V20190111 Service Flyer

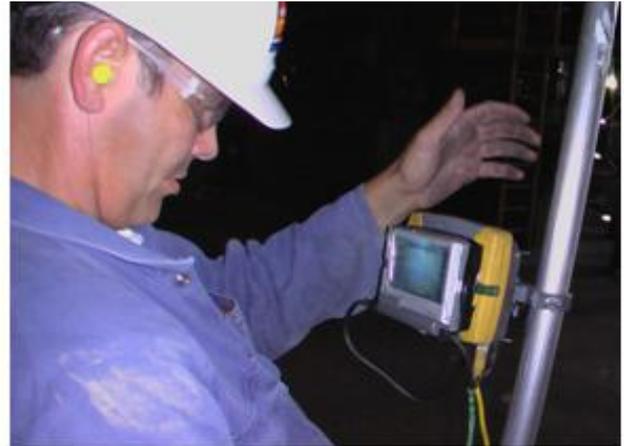
An imaging device is used to capture readings from difficult-to-access hangers.

HRL has developed an imaging device able to capture still and moving pictures of difficult-to-reach objects. The device can be used on a telescopic arm to help overcome inspection challenges by:
