# Ageing Aircraft Sustainment

## Optimising Aircraft Availability

Stress Corrosion Cracking  
Wing Panel Rib H-Clips  
AP-3C Orion

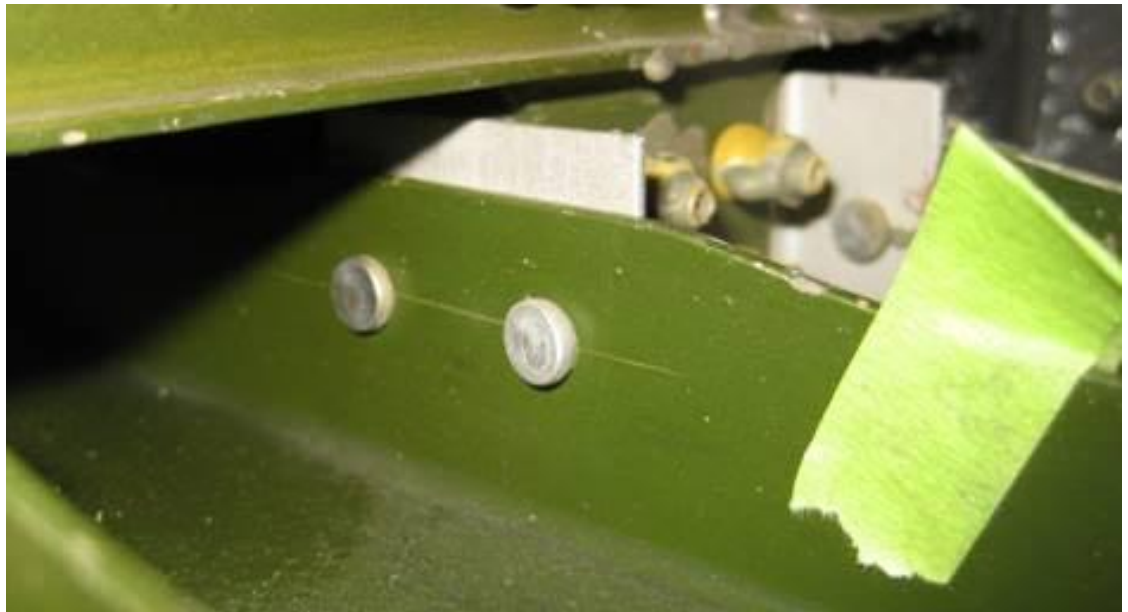
- Crack confirmed with surface scan
- NDT performed a visual sweep of the tank area
- Detected and confirmed a further 7 cracks

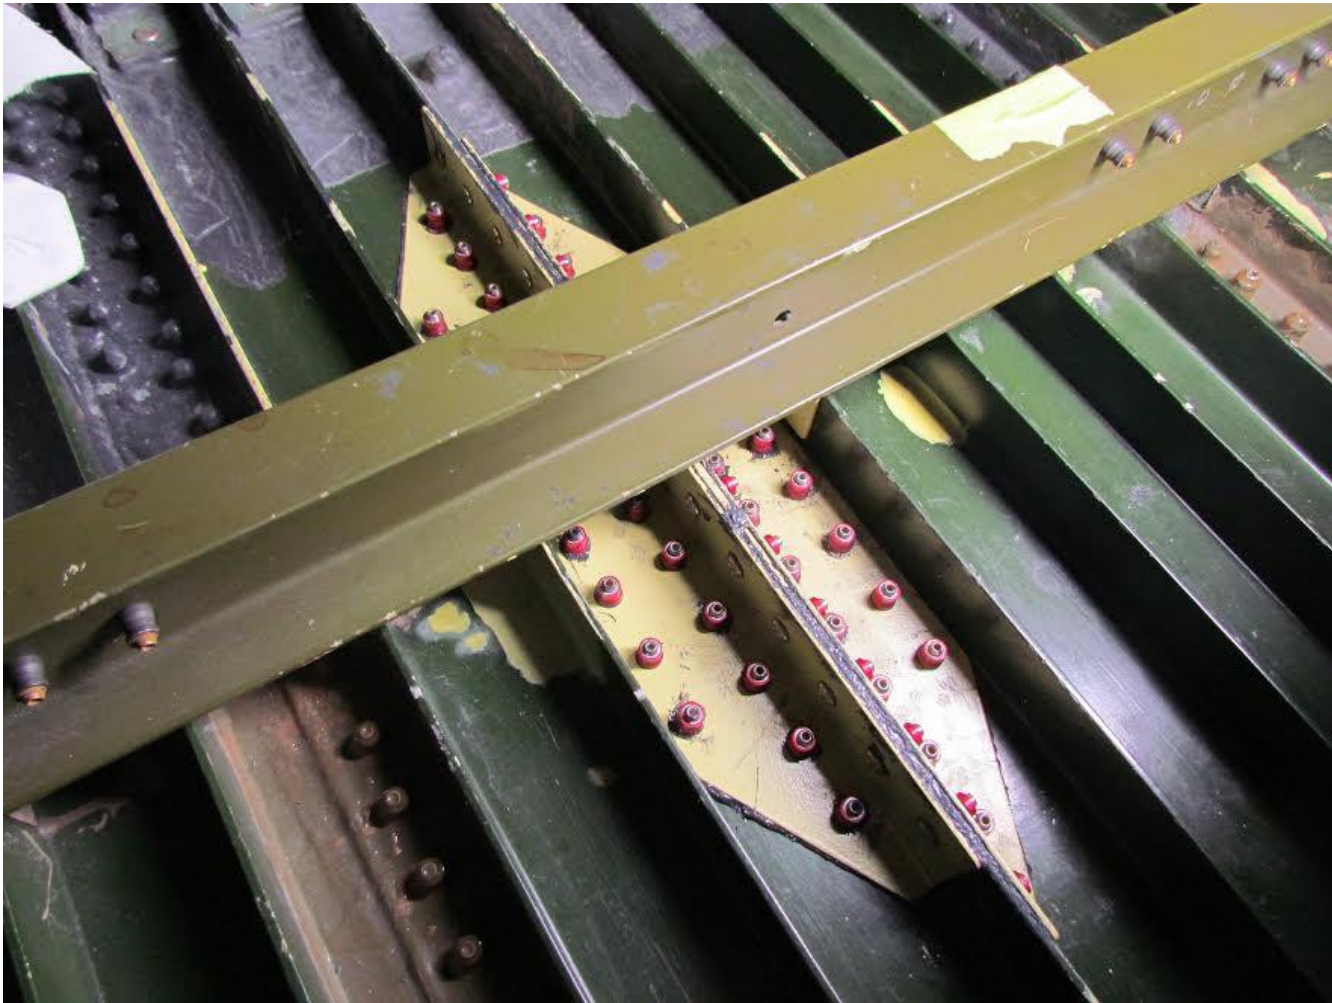
- Worked with the maintenance contractor to determine length of time to conduct inspections and any rectification actions
  - Impact on TMS and resources (personnel)
- Determined that full repair of each cracked site would create a heavy backlog for structural fitters and tank entry trained personnel
- Moved onto development of a more risk tolerant solution

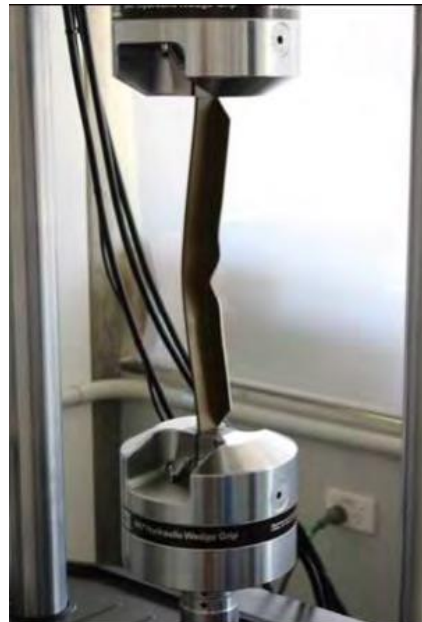
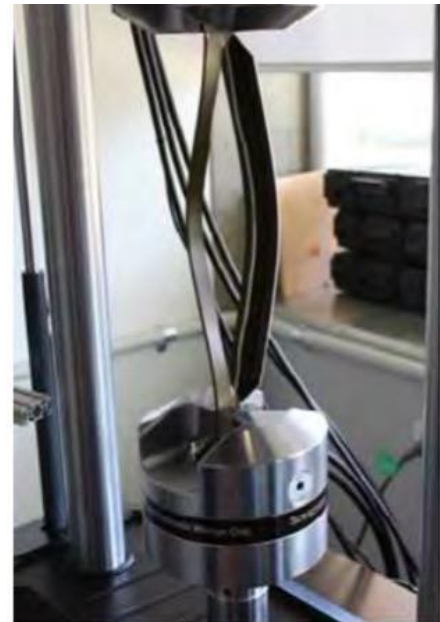
- Initial compressive strength testing conducted to assist in validation of design behind the STI – single riser test only
  - Laboratory EDM slots in the riser
  - Results from FE model and test were in good alignment

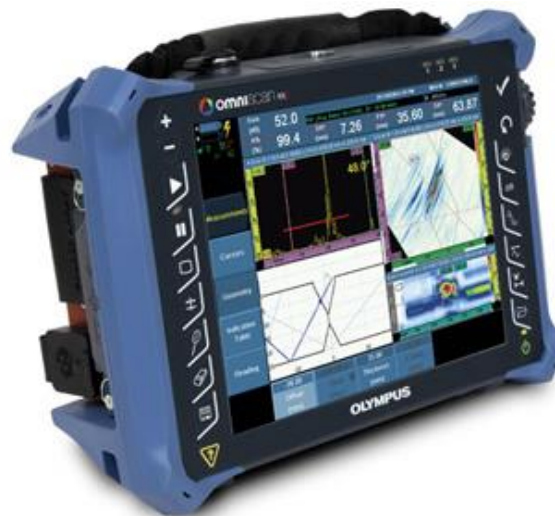
- Phased Array Ultrasonic inspection was identified as having significant potential
  - Successful on-aircraft trials have been conducted
  - Final approved NDT procedure yet to be released
  - Significant cost of equipment purchase is offset by the increased availability of aircraft once incorporated
