# Continued Operational Safety Risk Assessment of Textron Aviation's Commercial Fleet

July 5, 2018

# Textron Aviation's Commercial Fleet

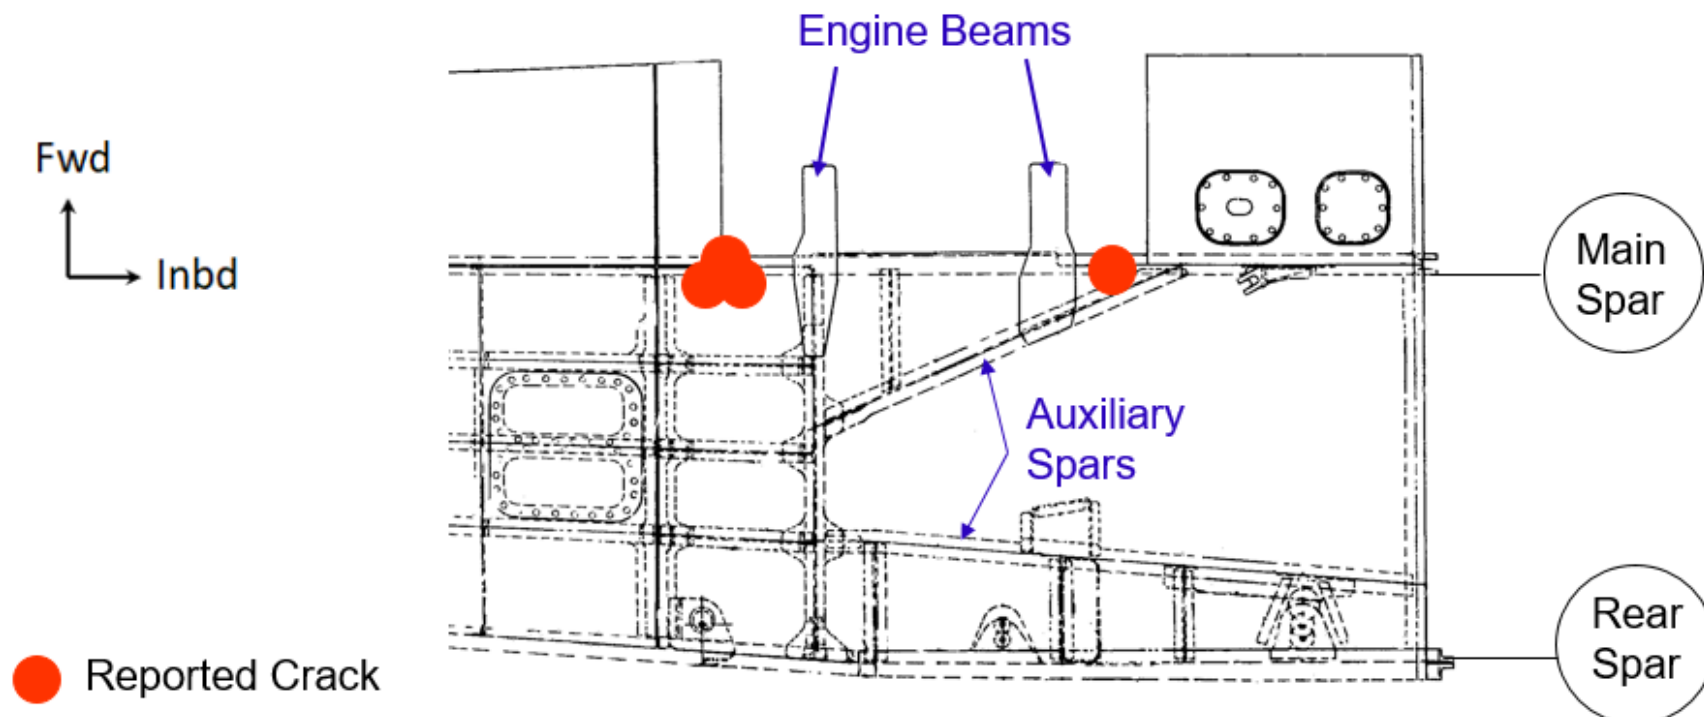
- Main Spar Cap Cracking
  - April 1999 - wing separation as a result of metal fatigue (20,457 Hrs.)
  - February 2005 - wing spar crack reported on scheduled airliner (20,349 Hrs.)
    - Two more wing spars found cracked the same week (20,510 & 20,349 Hrs.)
  - Airworthiness directive to install wing spar strap at 15,000 Hours

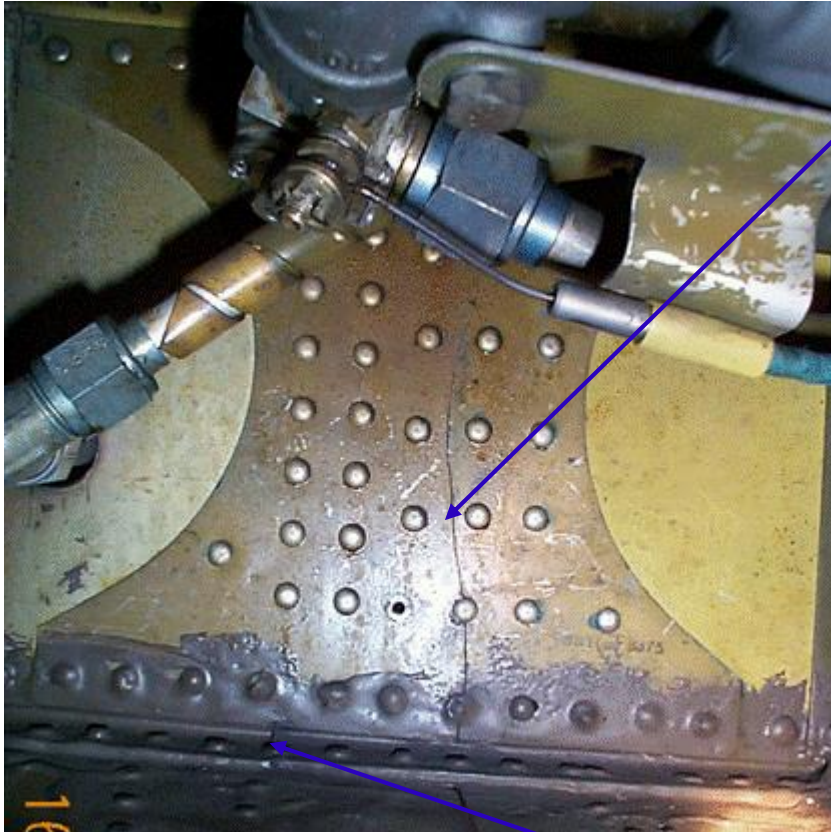
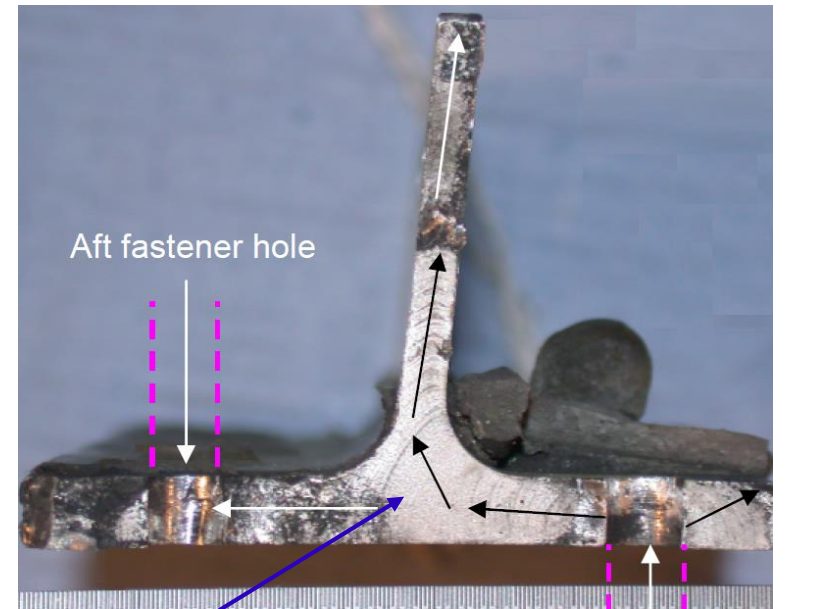
# Model 402C Fleet Wing Spar Cracks

Spar Splice Web Crack

Aft fastener hole

Forward fastener hole

Wing Front Spar Crack

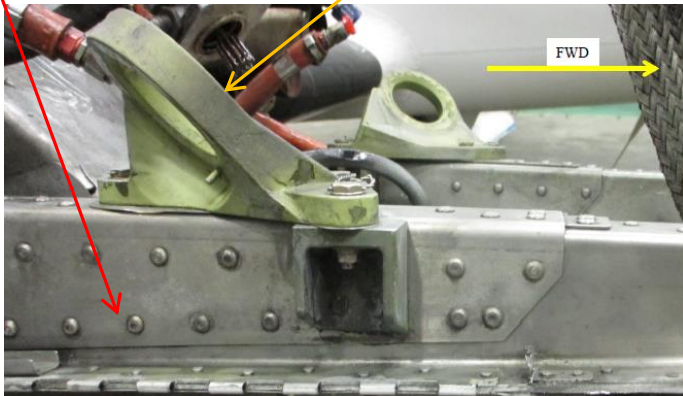
Added Doubler

New Aft Mount

- Engine Beam Cracking
  - New doublers (1981) and new aft engine mounts (1986) were added
    - Short cracks were stop drilled before adding doublers
  - February 2015 cracks were found growing from underneath the doublers (29,000+ Hrs.)
    - Eight more were found cracked in the next month (27,000 -38,000 Hours)
  - Airworthiness directive for 200 hour x-ray inspection
  - Life limit established for engine beams at 20,000 Hours

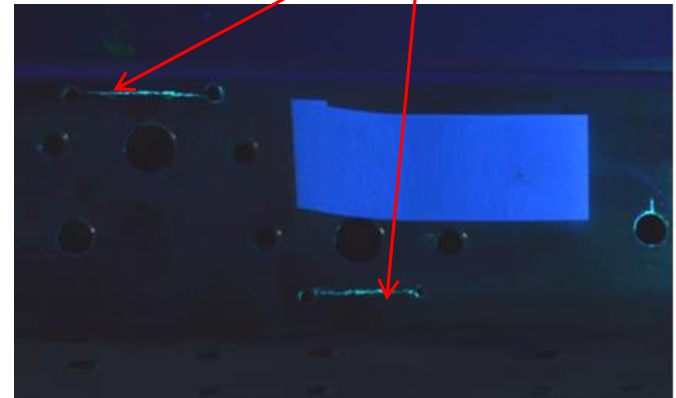
Stop Drilled Cracks

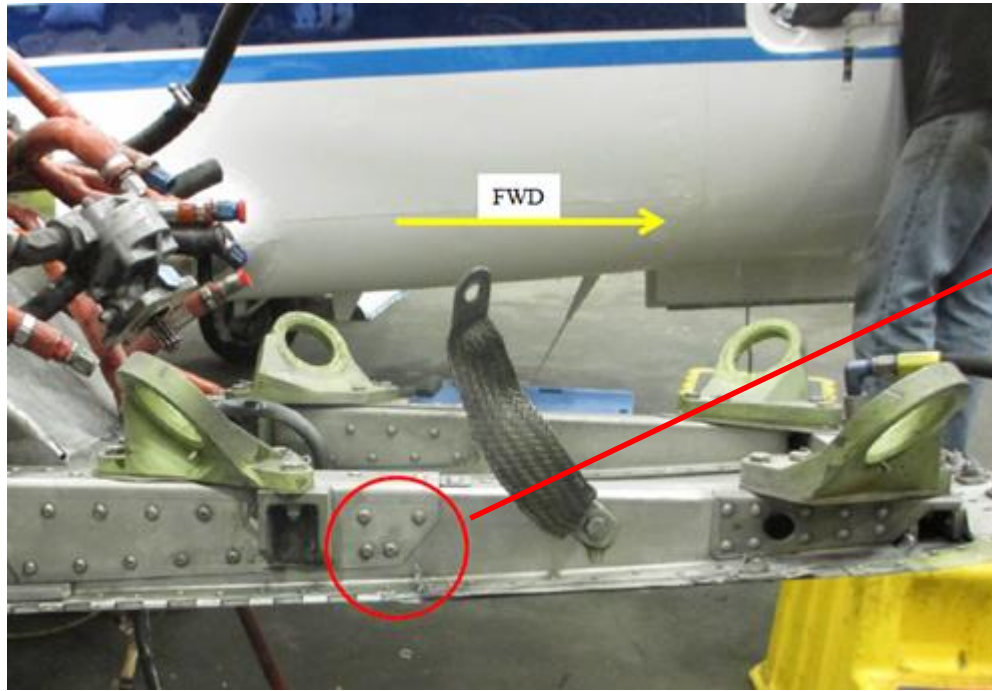
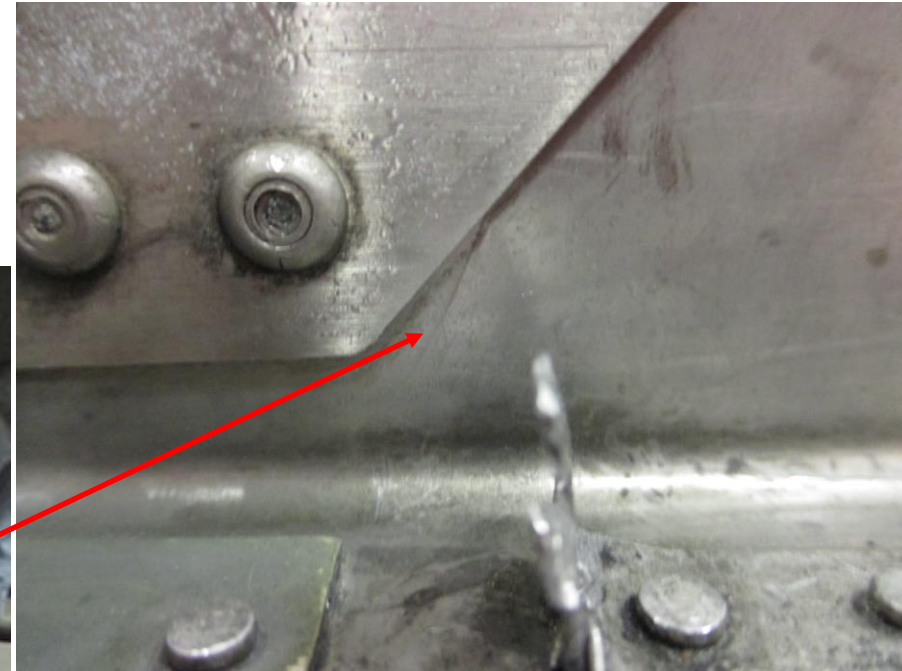
# Model 402C Engine Beam Cracks

→ FWD

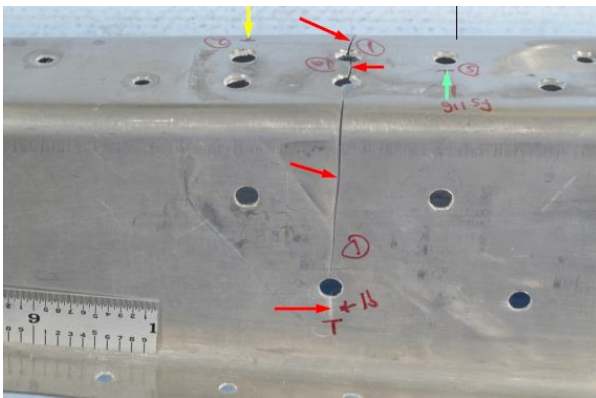
Side View

LH Outboard Beam  
 Fwd of Aft Engine Mt  
 29,000+ TTIS

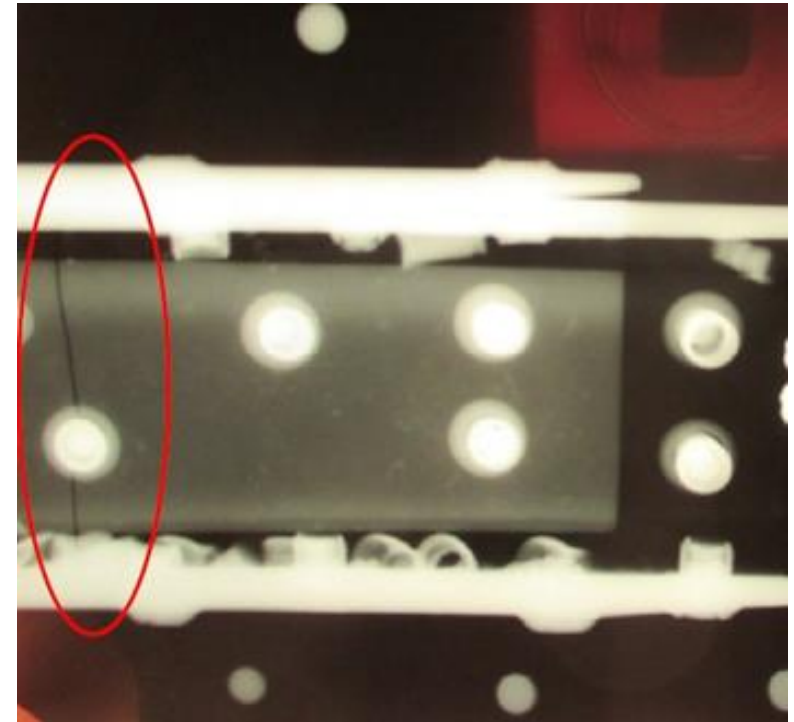
X-ray Image  
 LH Inboard Beam  
 Fwd of Aft Engine Mt  
 32,000+ TTIS

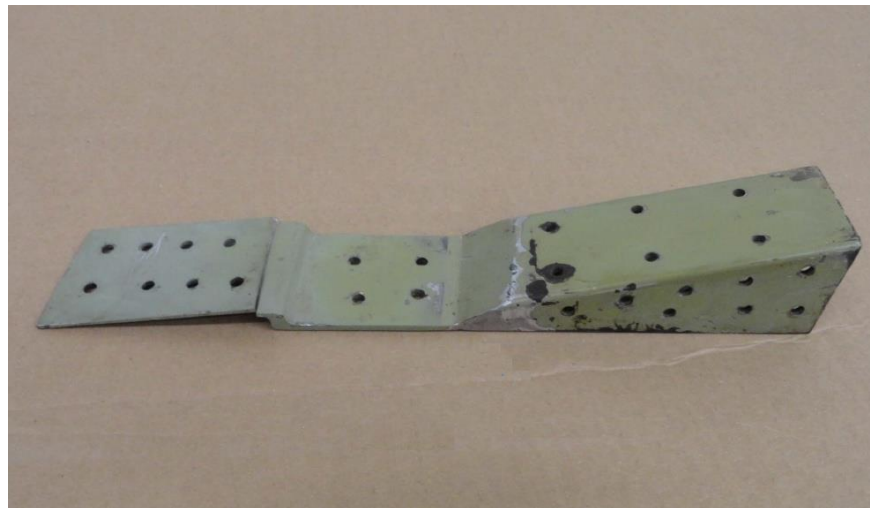
- Nacelle Fitting Cracking
  - Nacelle fittings - added by the wing spar strap modification
  - December 2016 - cracks were found in two nacelle fittings (14,000+ Hrs.)
    - An additional 25 fittings were found cracked
  - Two modes of cracking
  - Airworthiness directive to visually inspect for cracks via boroscope every 25-200 hours depending on time in service
  - Life limit established for fielded fittings

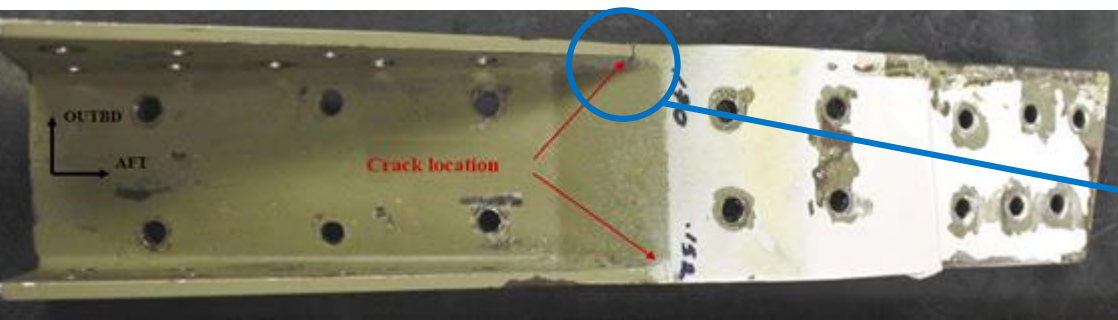
View looking up at lower surface

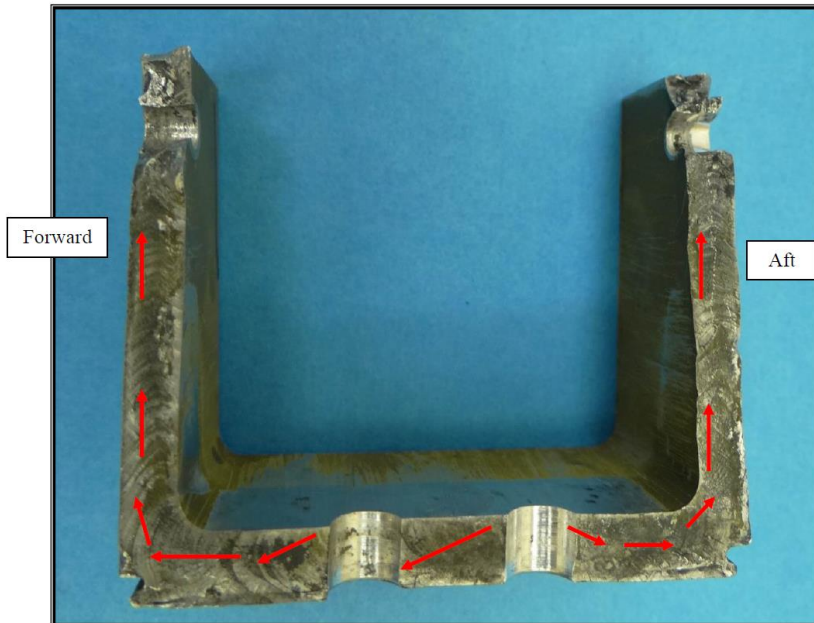
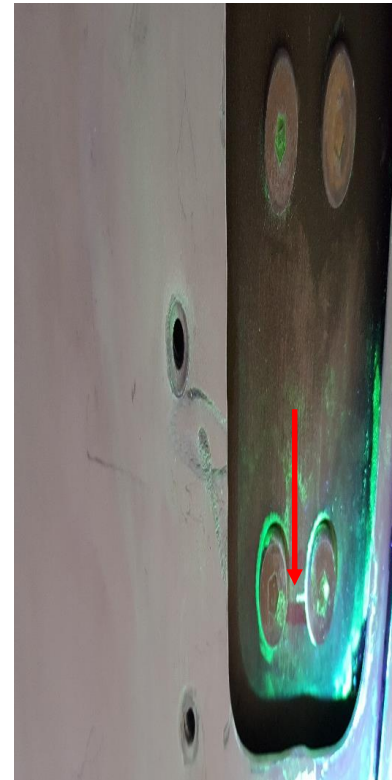
- Carry-thru Forward Lower Spar Cracking
  - Spar is common to all 300/400 series twins
  - April 2017 - Carry-thru spar found severed (35,000+ Hours)
    - Two additional spars found with small cracks at 15,000+ hours
  - Airworthiness directive to visually inspect spar caps every 50 hours
  - Automated bolt hole eddy current inspections
    - Model 425 will be life limited

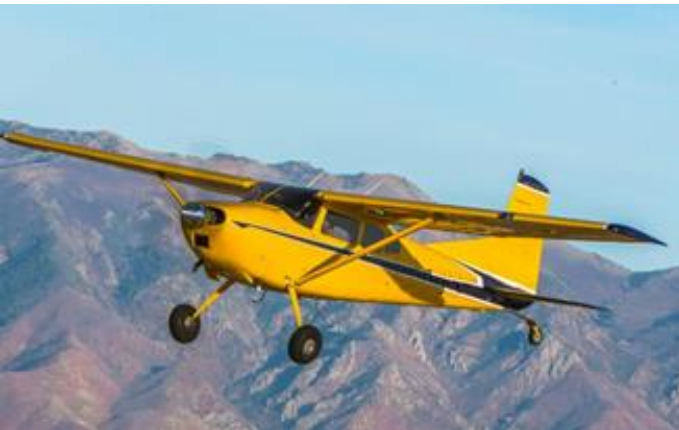
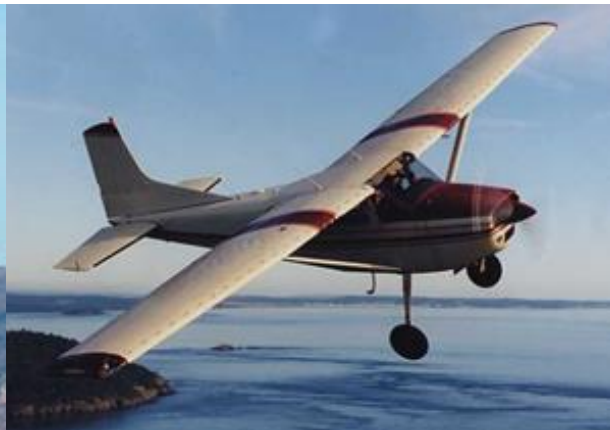
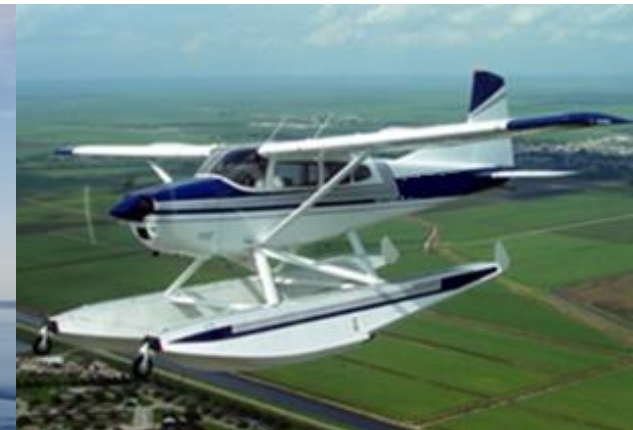
- Horizontal Stabilizer Structure Cracking
  - Tailcone reinforcement angle found cracked at horizontal stabilizer attachment
    - 27 cracks found (2,700 -14,000+ Hrs.)
    - Stabilizer attachment bolt passes thru reinforcement angle
  - Cracks also noted in:
    - Horizontal stabilizer hinge bracket
    - Stabilizer hinge reinforcement channel
    - Stabilizer hinge assembly
    - Aft spar and aft spar reinforcement
  - Airworthiness directive is being considered for 500 hour visual inspection

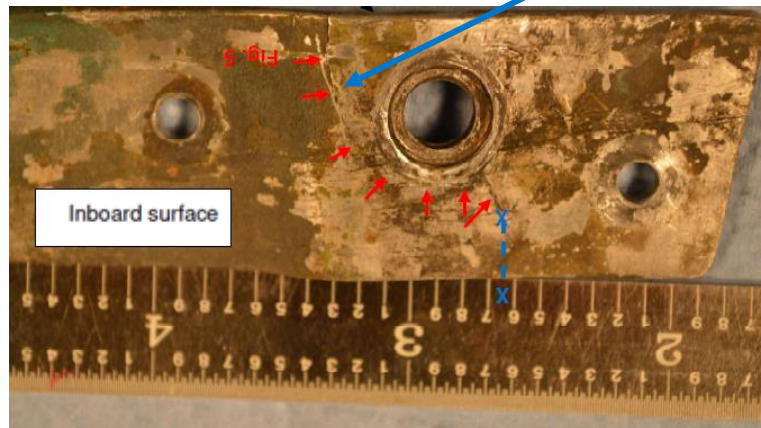
Stabilizer Hinge  
 Bracket  
 Reinforcement  
 Angle

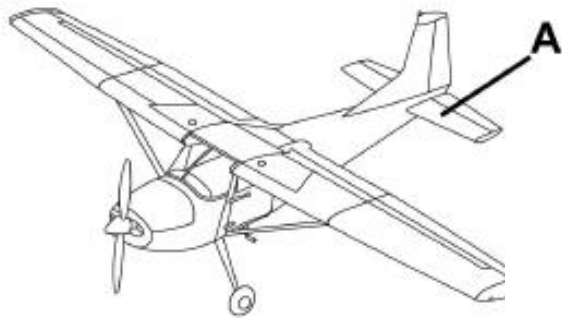
Stabilizer Hinge Assembly

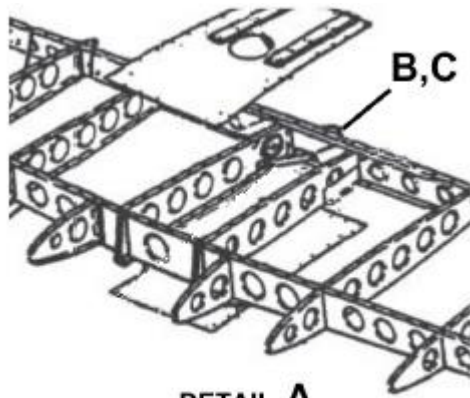
**DETAIL A**

Looking Aft Skin Has Been  
Removed For Clarity

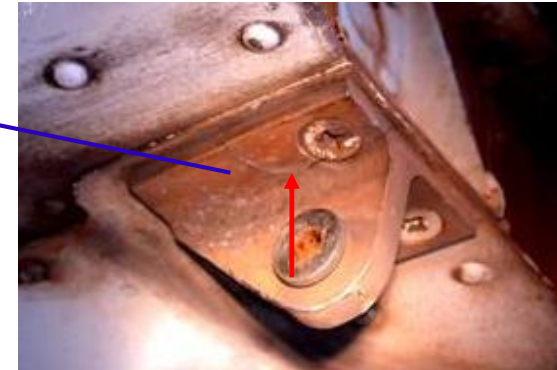
Stabilizer Hinge Reinforcement Channel
