Brake Cooling Hydraulic Systems on CAT 994H Loader Guarded by MAG-SHIELDS®

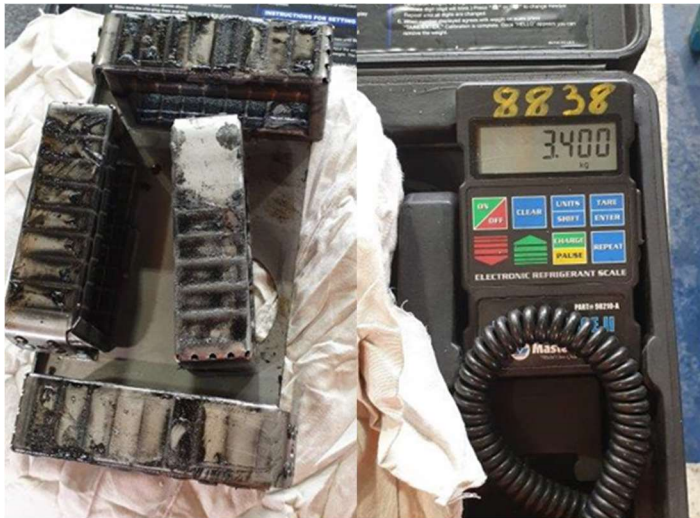
**MAG-SHIELD® After 5154 Hours
of Normal Operation (No
Failure) (3.4 kg)**

These images represent Mag-Shield performance over a period of 5000 hours, in a 994H loader operating at an Australian mine site. During this timeframe, there were no failures within the brake cooling circuit. Over the course of normal operation, 50 grams of ferrous material was collected by the Mag-Shields. Capturing the material that is produced during normal operation is key to improving oil cleanliness and component life, which helps mitigate failures. The result: less disruption for operations, planning and maintenance; improved availability and significant savings.

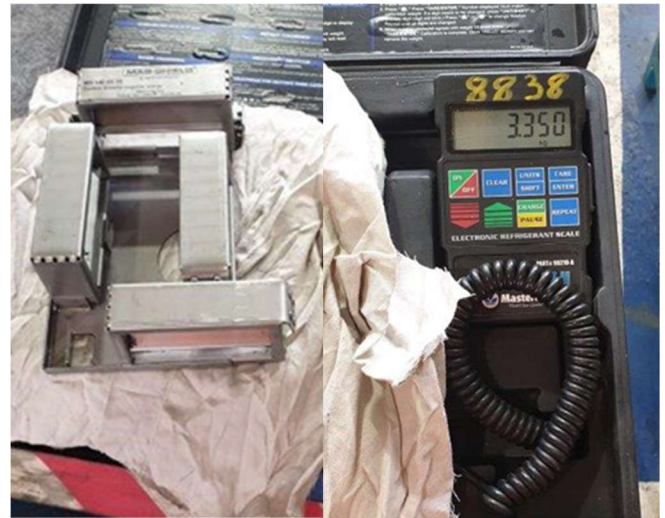
**Clean MAG-SHIELD® Indicating
50 grams of Ferrous Material
Contamination**
