## CASE STUDY: Paradise Gorge

A section of the Tasman Highway, near Orford Tasmania, is bounded by the Paradise River and 30m high dolerite cliffs that form the Paradise Gorge. Minor rockfalls had been reported from the cliffs impacting the road. Geotechnical assessments indicated that a section of the dolerite rock presented an unacceptably high risk to the public. Consequently, the Department of State Growth Tasman closed the Tasman Highway for 6-weeks to perform emergency remediation works involving the removal of over 2,000 tonnes of boulders from the rock face. Geotechnical assessment and remedial works design was undertaken by **pitt&sherry**. Surveying, 3D digital modelling and rock slope monitoring was undertaken by **Veris**.

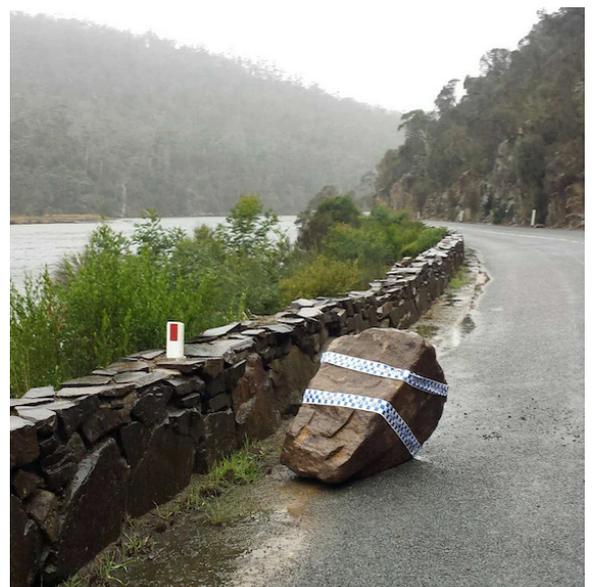
*A boulder that was dislodged previously due to wet weather*

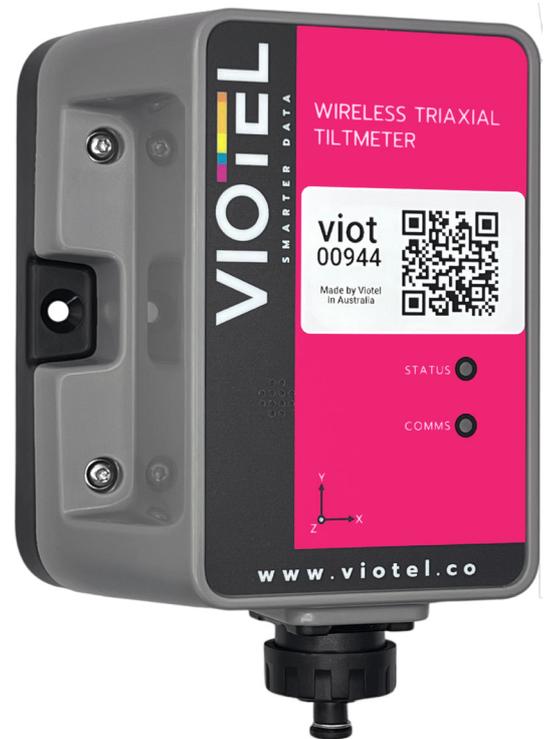
*Viotel Wireless Triaxial Tiltmeter*

The **Viotel** Nodes are safe, self-contained IoT sensor packs which are discrete, simple to install and calibrate, powered with mains/ battery &/or solar power and with analysis power via on-board microprocessors.

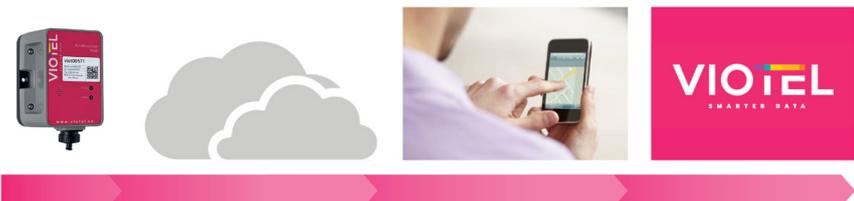
Integrated data path from source to decision

The **myViotel** platform, accessing Cloud-based data, transforms a sensor from a disconnected unintelligent asset to a networked live data device. Each **Viotel** Nodes has GPS location and the **myViotel** platform automatically searches for and sources the nearest weather station data from the Bureau of Meteorology, which with appropriate nodes can provide insights on groundwater response and ground movements in relation to weather events.
