PC-9 Ageing Aircraft Challenges

Wing Commander Ashley Howell
Commanding Officer
Air Training and Aviation Commons System Program Office

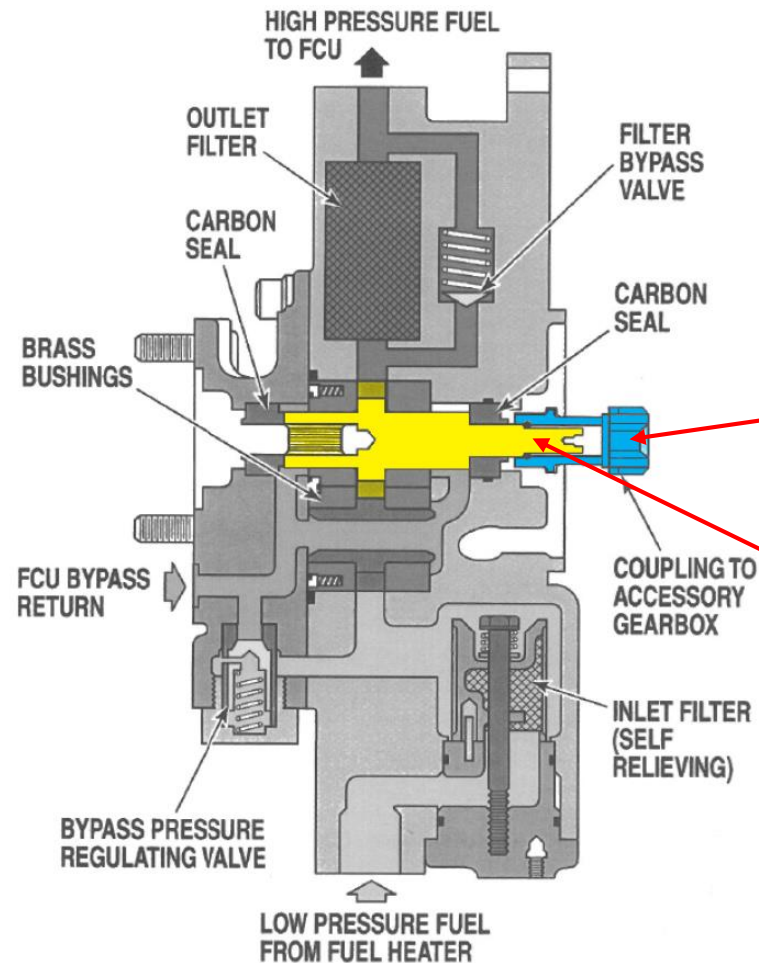
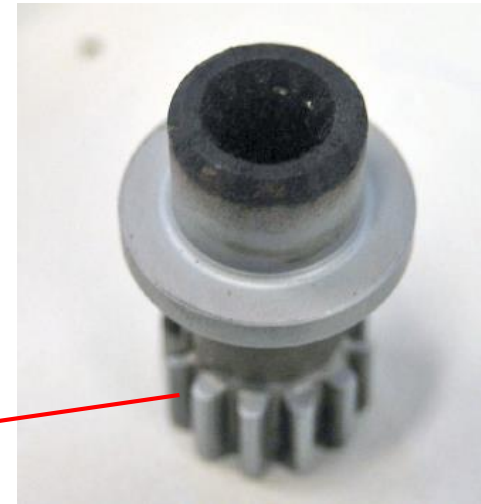
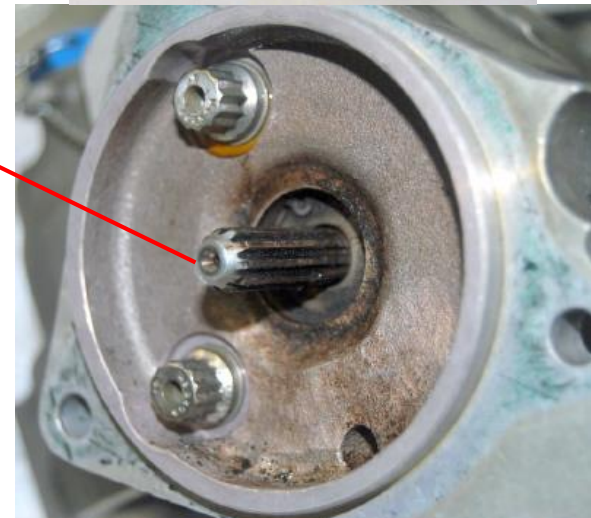
High Pressure Fuel Pumps (HPFP)

- Failure mode consistent with the cause of the May 2011 crash of A23-039; undetected wear failure of the HPFP driveshaft spline.
- The engine failure occurred 3nm from the RW04 RAAF East Sale at approx. 3,600ft AGL.

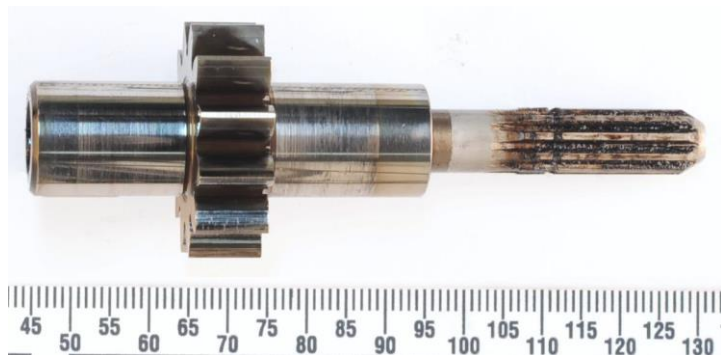
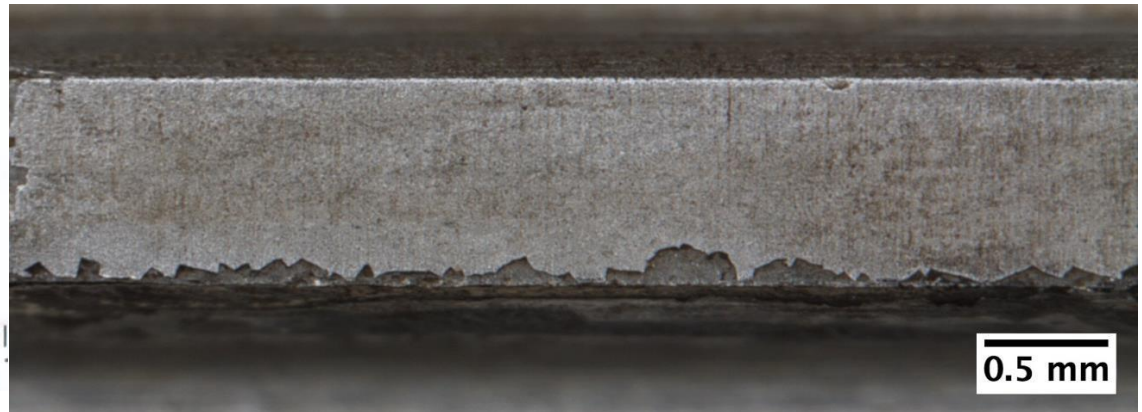
- DSTG analysis identified the composition of the black substance was consistent with fretting debris from the coupling mixed with lubricating oil, specifically being comprised of carbon with metallic components consistent with the steel coupling alloy AMS6470 and chromium plating.
- This fretting wear can be self-accelerating. The wear rate was not predictable.

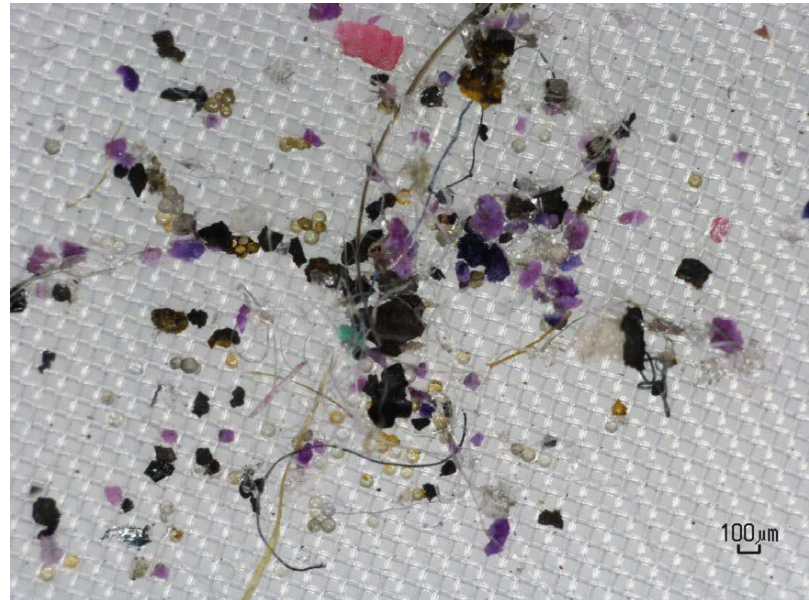
- Quinizarate metal salt occurs when oil containing quinizarin reacts with magnesium oxide.
- The presence of quinizarate metal salt on the outside of the RGB rear case confirmed that the corrosion has penetrated the case in several areas.

- Engineering actions:
 - Released inspection program to conduct borescope inspections of the exhaust case area for indications of gross magnesium oxide debris.
 - Borescope inspections are conducted every seven days as part of the compressor wash servicing.
 - Capture and analyse compressor wash water from the exhaust casing for the presence of MgO.
