Repair of aircraft components with Additive Manufacturing Laser Cladding Technology – Examples and Modelling

Kevin Walker¹, Qianchu Liu¹ and Tim Cooper²

AA&S Conference

Brisbane, Australia, 19-21 July 2017

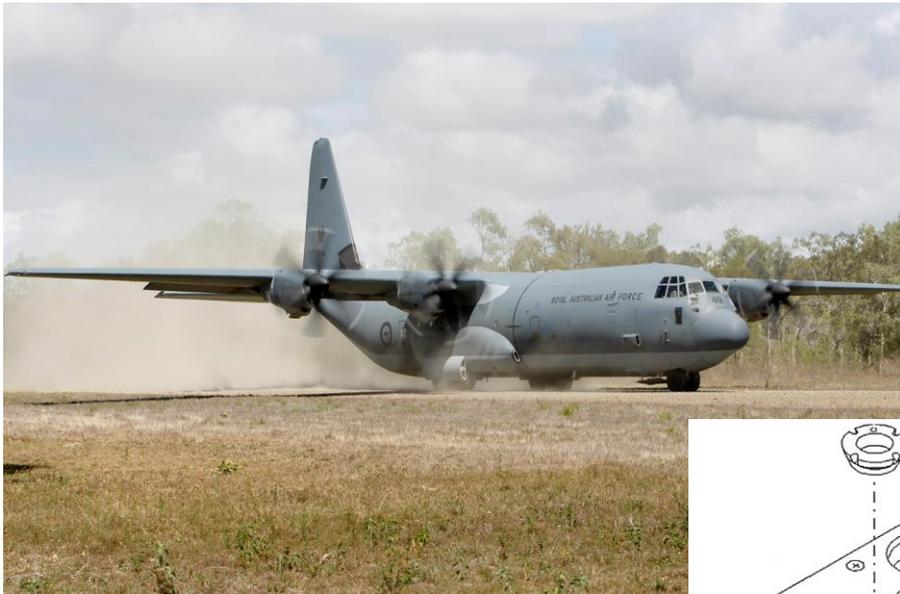
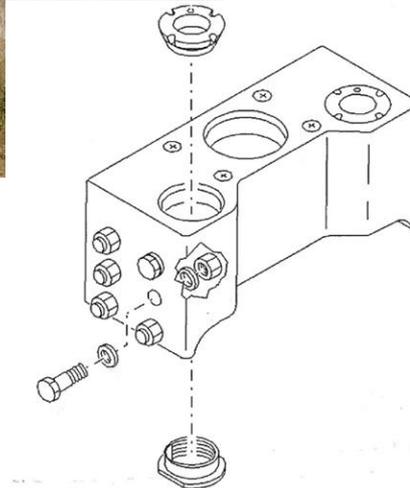
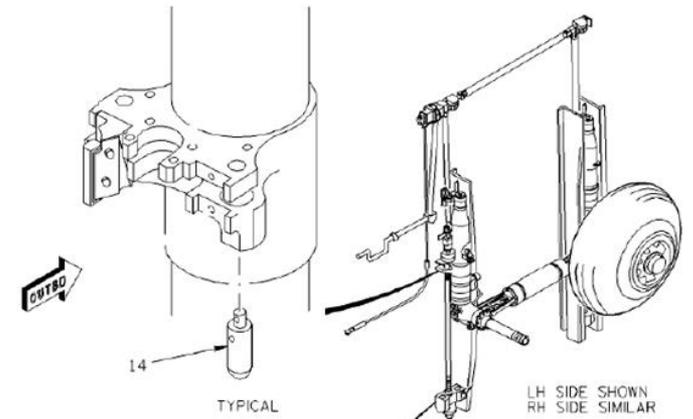
Laser Cladding Repair C-130J Landing Gear Shelf Bracket Corrosion

- 4140 steel forging
- Corrosion in drag pin holes
- Corrosion damage depth limit is very conservative – maximum allowable depth 12 μm , 0.0005 in
- Typically find 3 out of 4 brackets need to be replaced at 6 yearly depot servicing

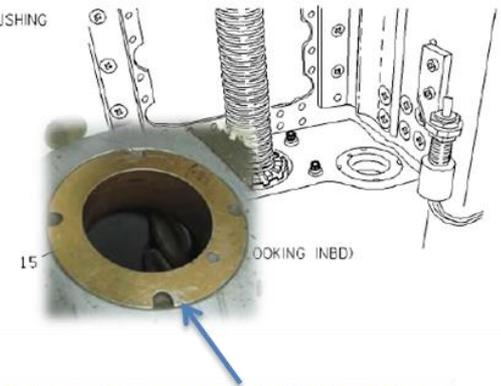
Bushing Inserted (Nitalloy 135 Modified)

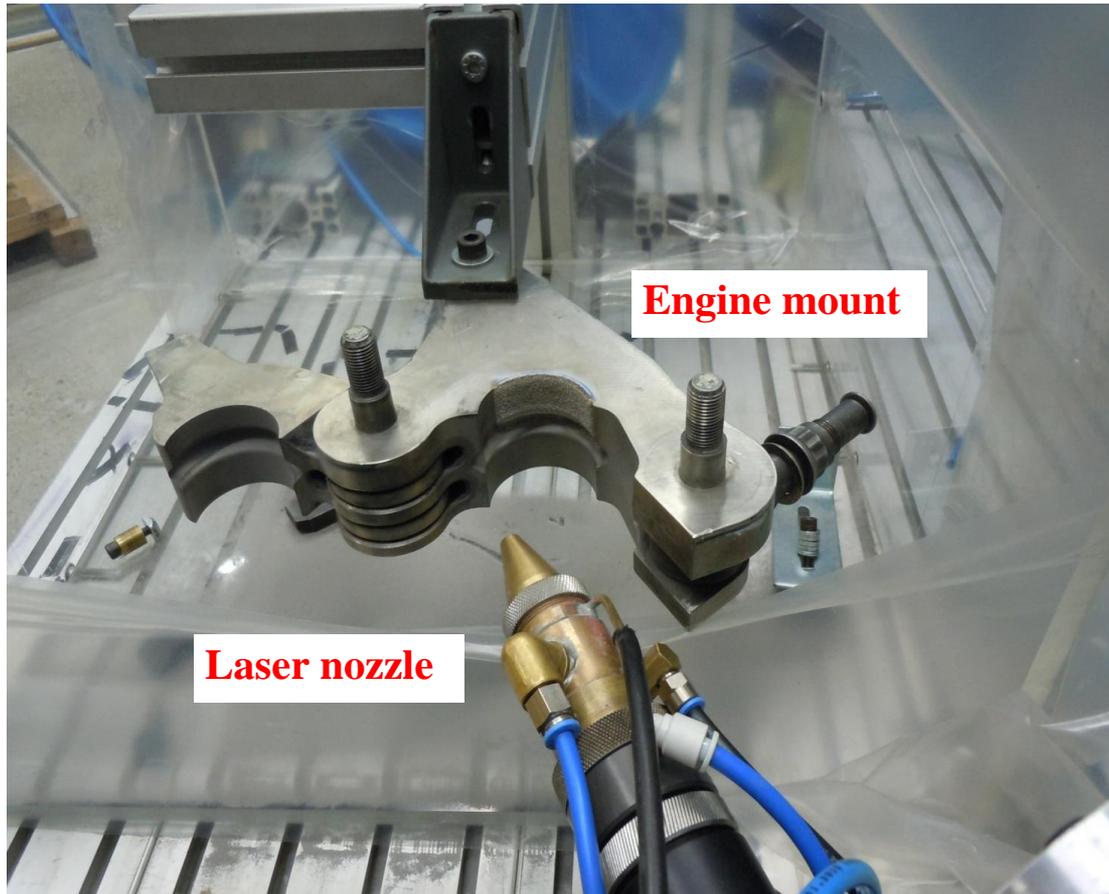
Set-up for repair at Swinburne University

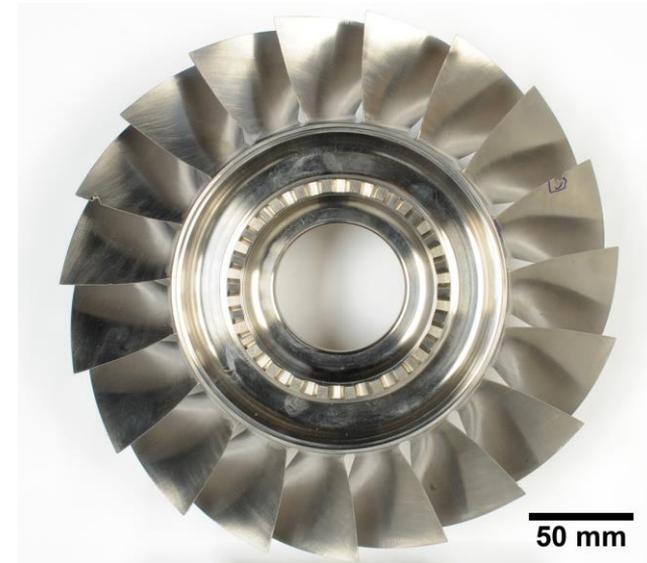
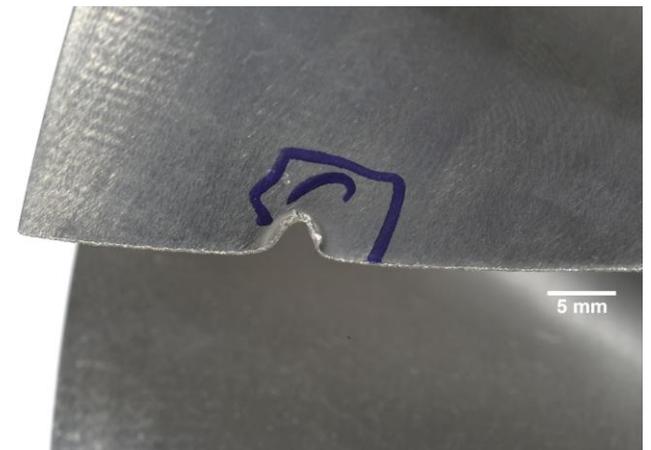
AM Repair of Dynamic Engine Components

- FOD impacts to integrally bladed engine compressor rotors can render these high-value components unserviceable.
- Impact damage can be repaired by two methods – subtractive and additive.
- Subtractive repair involves grinding out and blending the damaged area. This can affect the high-cycle fatigue response of the component.
- Additive repair uses laser powder deposition to rebuild the damaged area, restoring it to its original geometry.
- Challenges for AM repair of dynamic components, such as Ti-6-4 rotors, include the effects of heat affected zones, achieving desirable microstructures in the repair material, and defects such as porosity.

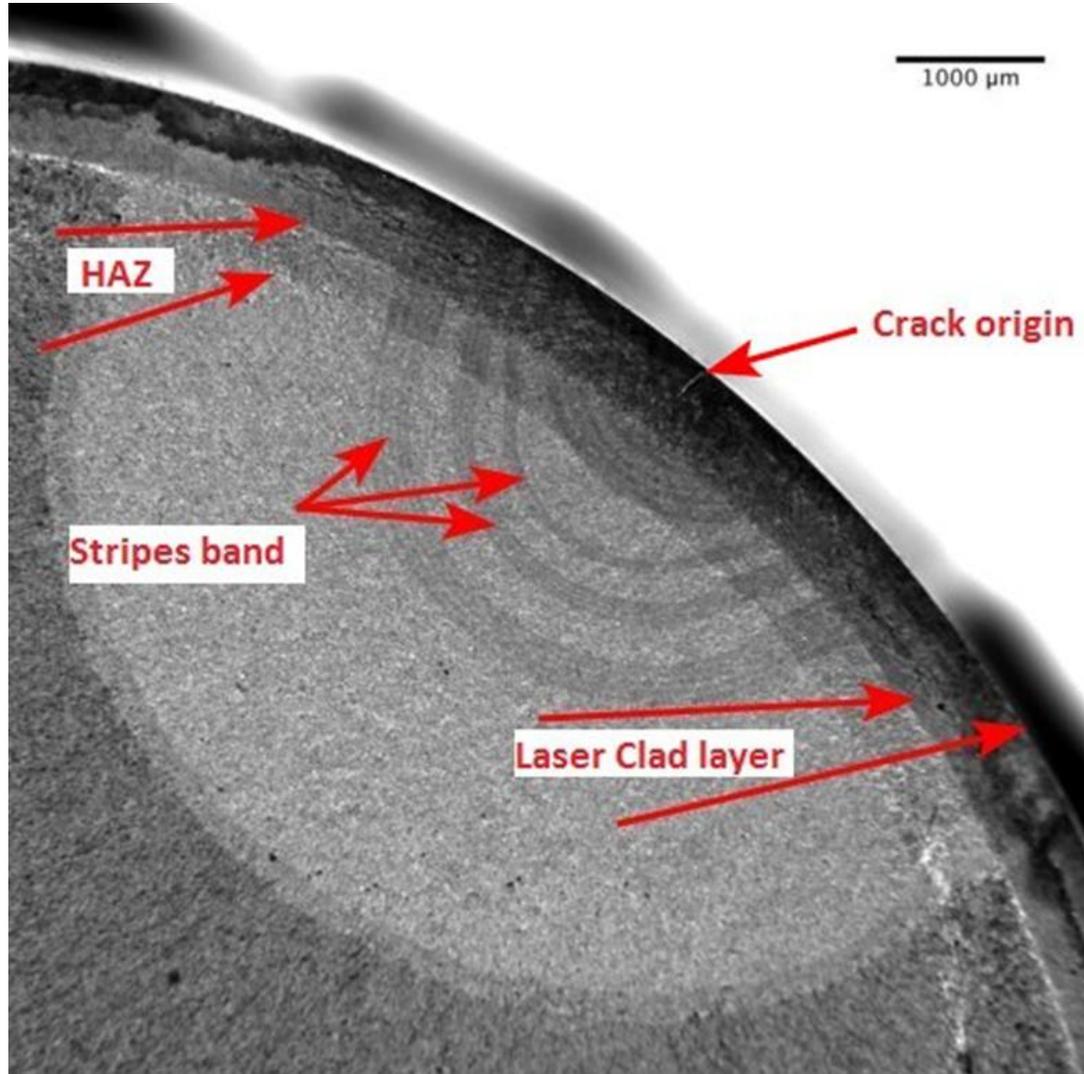
Test Results : As-clad

- Slow fatigue crack growth due to the compressive residual stress in clad layer
- Ability to restore strength and fatigue life is very promising
- Crack growth modelling being updated with recent X-Ray diffraction results – expect an improvement
- Ability to model the residual stress behaviour will greatly improve our capability to design these structural repairs – to be discussed next by Tim Cooper

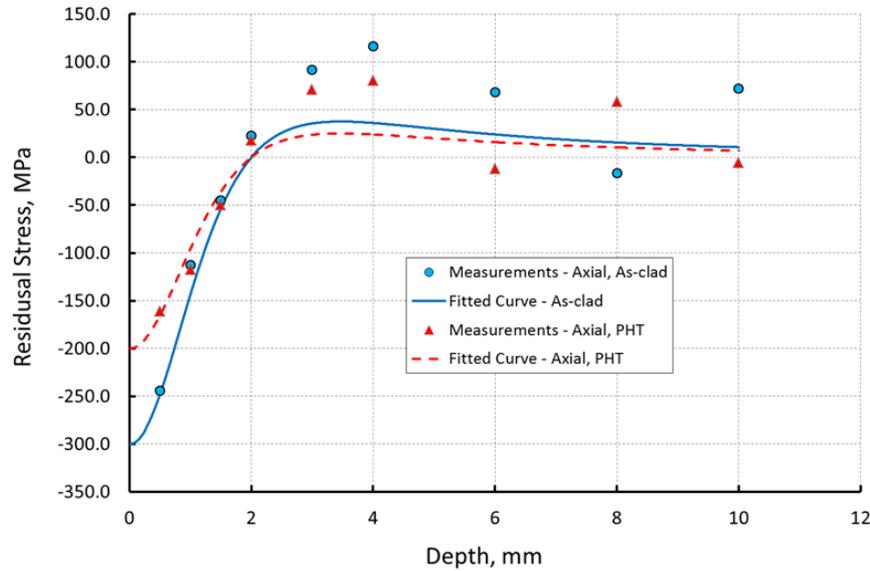
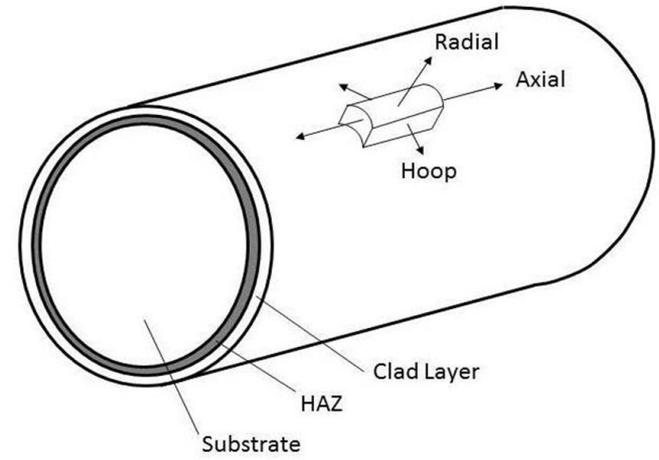
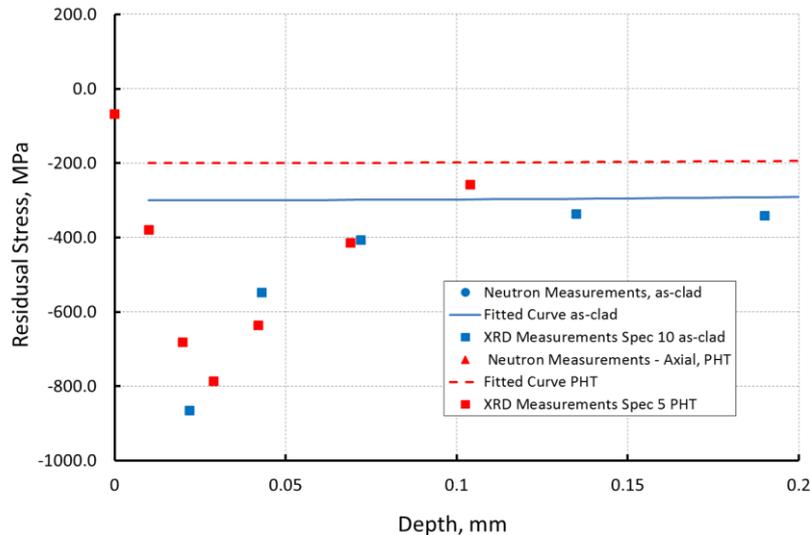
Residual Stress Measurement

$$\sigma_R(z) = \sigma_{R,\max} \frac{1 - (z/d)^2}{[1 + (z/d)^2]^2}$$

Satisfies the zero net force condition
