ID Fan Capability

Optimising induced draft fan performance and reliability

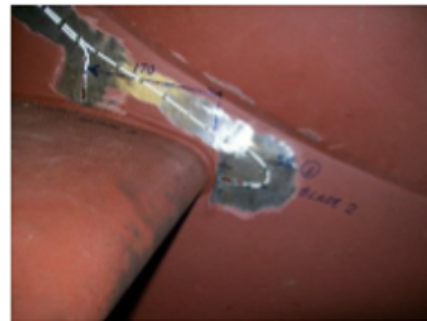
Strain gauging on an ID fan impeller to survey strain during operation

- installing (wireless) strain gauges onto the new impeller to survey strain during start-up and normal operation
- undertaking a finite element analysis (FEA) of the fan to determine the resonant frequency of the impeller and mode shape of the natural frequencies
- undertaking steady-state analysis to compare the operating mean stress of the new impeller to the original
- performing a stiffened modal analysis to determine the system's natural frequencies and modal shapes
- performing an unstiffened modal analysis to determine static natural frequencies for validation against impact testing results
- performance testing of the fan during operation to determine its efficiency under different operating conditions.
