Trainer Aircraft ASIP Case Study

A Presentation to: 2017 Aircraft Airworthiness and Sustainment Conference

PC-9/A Empennage and Aft Fuselage Recertification and Life Assessment Program, Presentation at DGTA-ADF ASI Symposium 2011

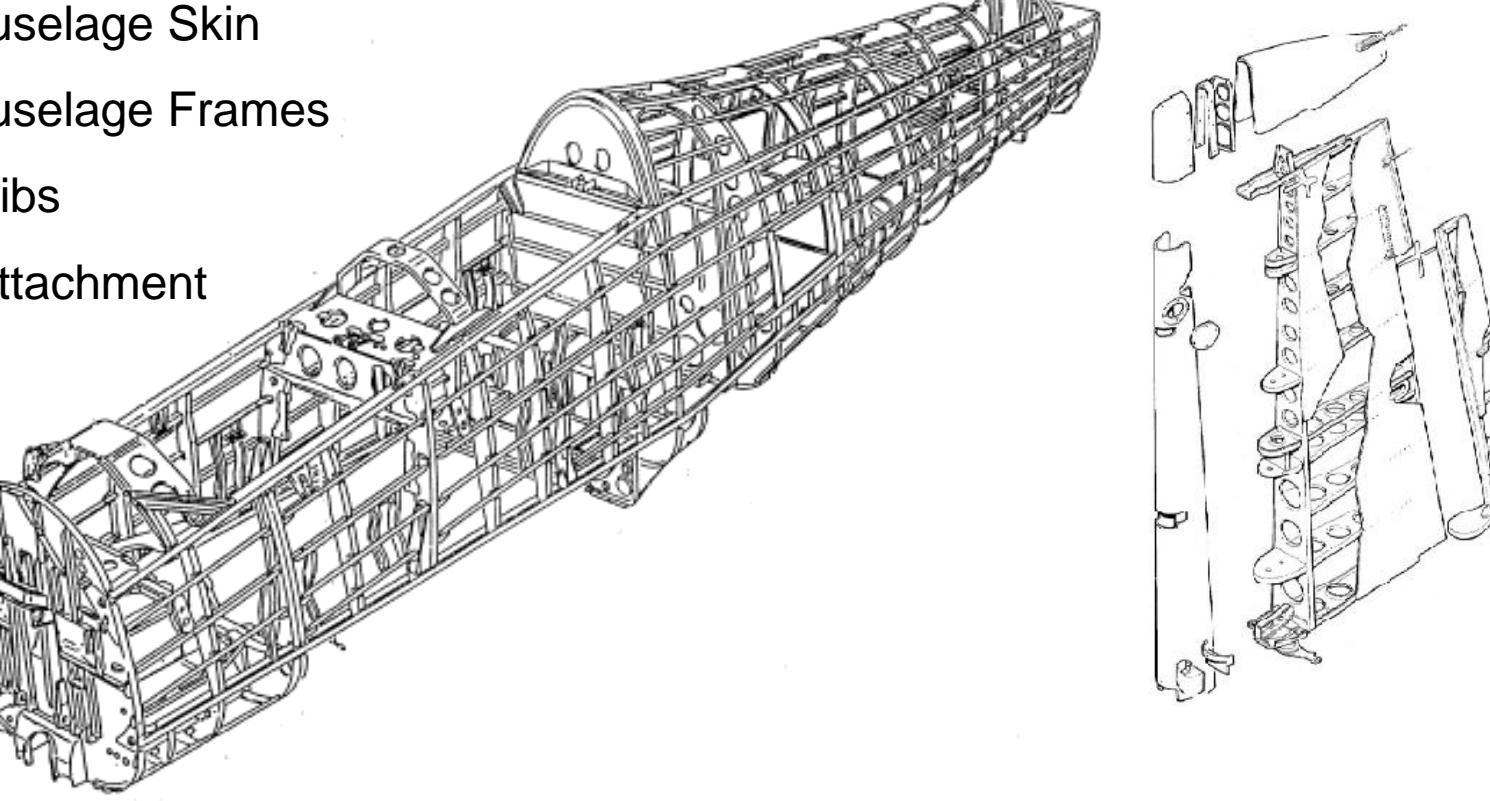
3. Unexpected in-service Cracking

- Fatigue cracking prior to Safe Life Limit established through FSFT, • especially in aft fuselage structure
 - Aft Fuselage Skin
 - Aft Fuselage Frames
 - Fin Ribs
 - **Fin Attachment**

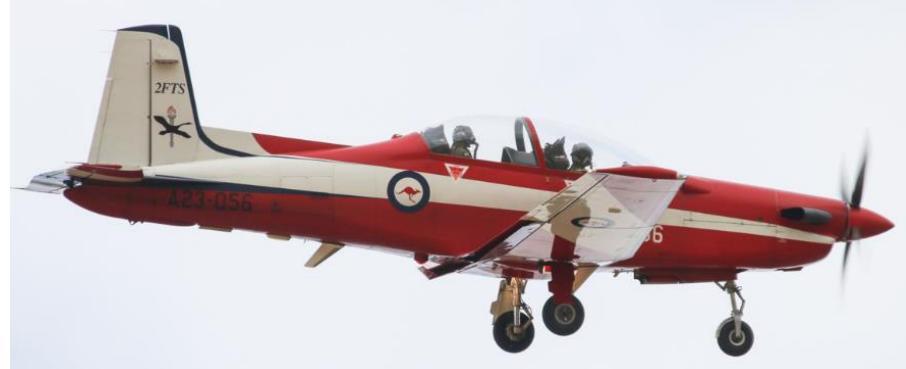
6. Initial Mitigation

- Risk assessment- Retained medium residual risk
- Operational Loads Monitoring Program (DSTG, Pilatus, QinetiQ for TASPO)
 - Strain gauges and accelerometers; ground and flight test program; identify and quantify loads
 - FEM; Local stress; manoeuver loads and high frequency buffet
 - Stress sequence
 - Fatigue life analysis
 - Identify new hotspots
- Adjust Inspection Program for aft fuselage
- Tear down of high life aircraft considered, to supplement OLM

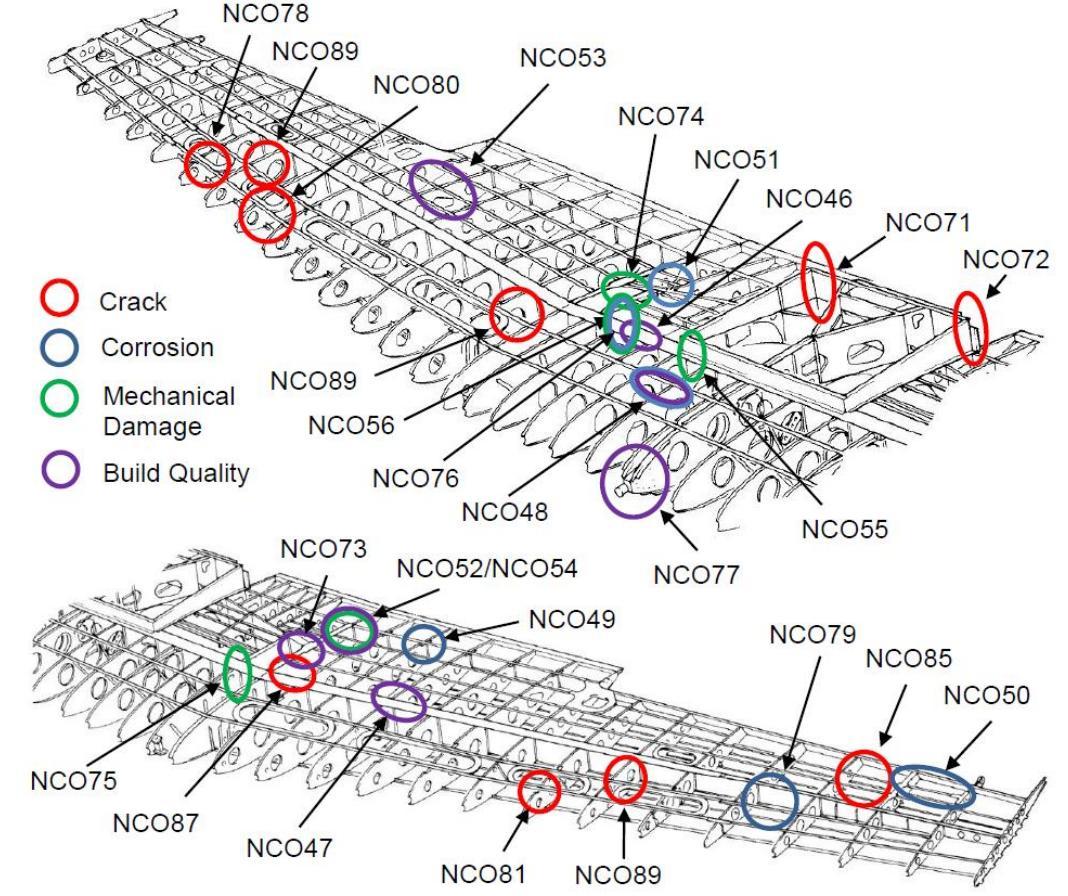
9. Ageing Aircraft Structural Audit - Teardown

- Teardown article in overall reasonable condition.
- Damage found in
 - Safety By Inspection (SBI) locations.
 Deficiencies in the extant SBI practices!
 - Previously uninspected primary structure.
- Examples of findings:
 - Fatigue cracks, extensive corrosion pitting and SCC.
- Action for fleet
 - Fleet inspection, parts replacements, repairs
 - Expand inspection program

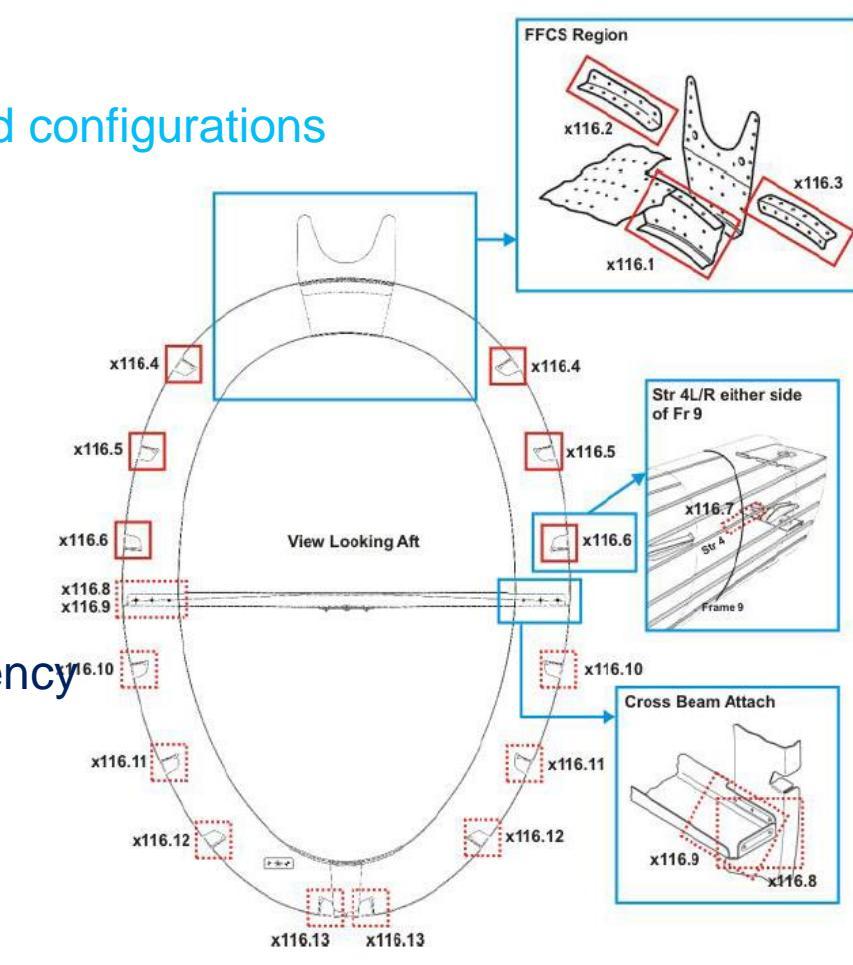
11. ASIP Recovery – Consolidation of SBI Locations

Example - Frame 9:

- SBI to include all inspection locations and configurations rather than having
 - four different SBI locations with
 - varying thresholds and intervals that require
 - different NDT reports, etc.
- Consolidation improved clarity and efficiency^{16.10}
 of the SBI program by
 - reducing the number of inspections and
 - rationalising inspection intervals
